Owasco Lake Watershed 2017 Roadside Ditch Assessment

Road Ditch Assessment Sites in Locke (Cayuga County)

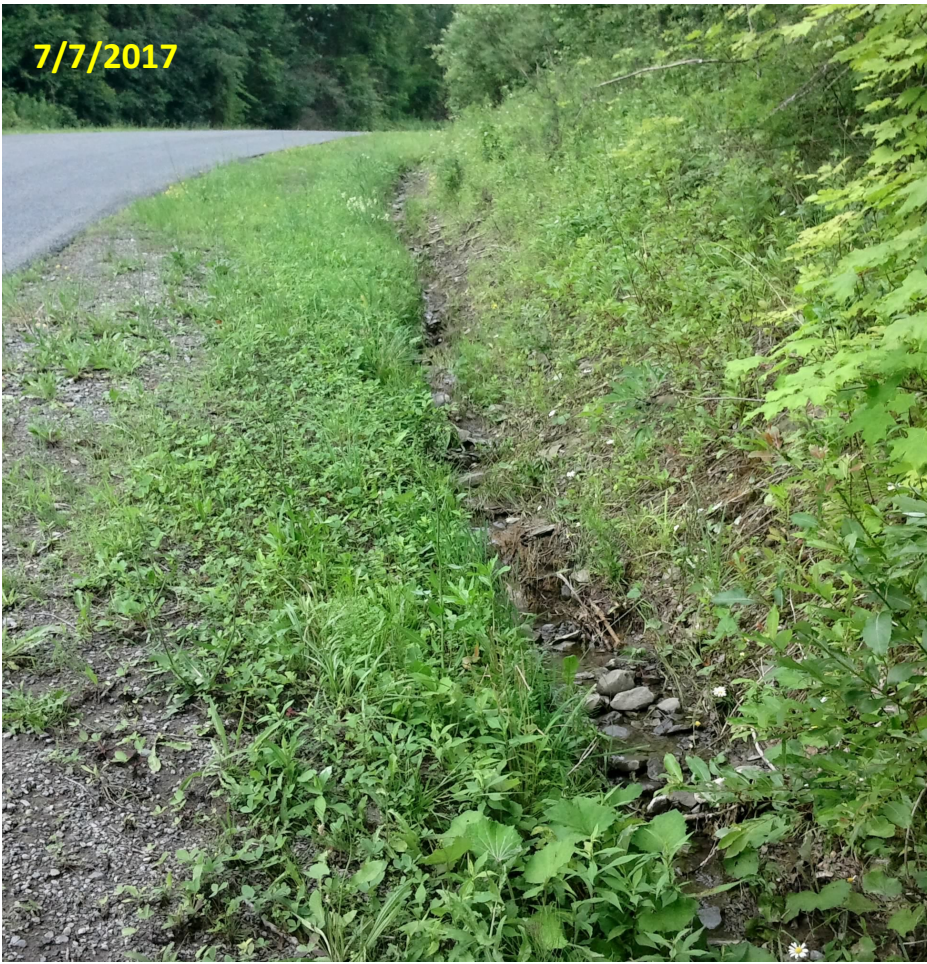
Map Identifier: Site 96
Sub-watershed: Owasco Inlet
Road Name: Main Road
Town: Locke
Road Jurisdiction: Town of Locke
Closest Intersection: Main Road/West Hill Road
Direct connection or proximity to a stream?: Yes
Percent Vegetation & Type: 50% Grasses
Level of Erodibility: Moderate
Slope of Area: Moderate Grade
Length of Ditch: 100 ft
Management Recommended: Hydroseeding
Resolvability: Moderate

Rank: Moderate (Score = 35)
Estimated Cost: \$150

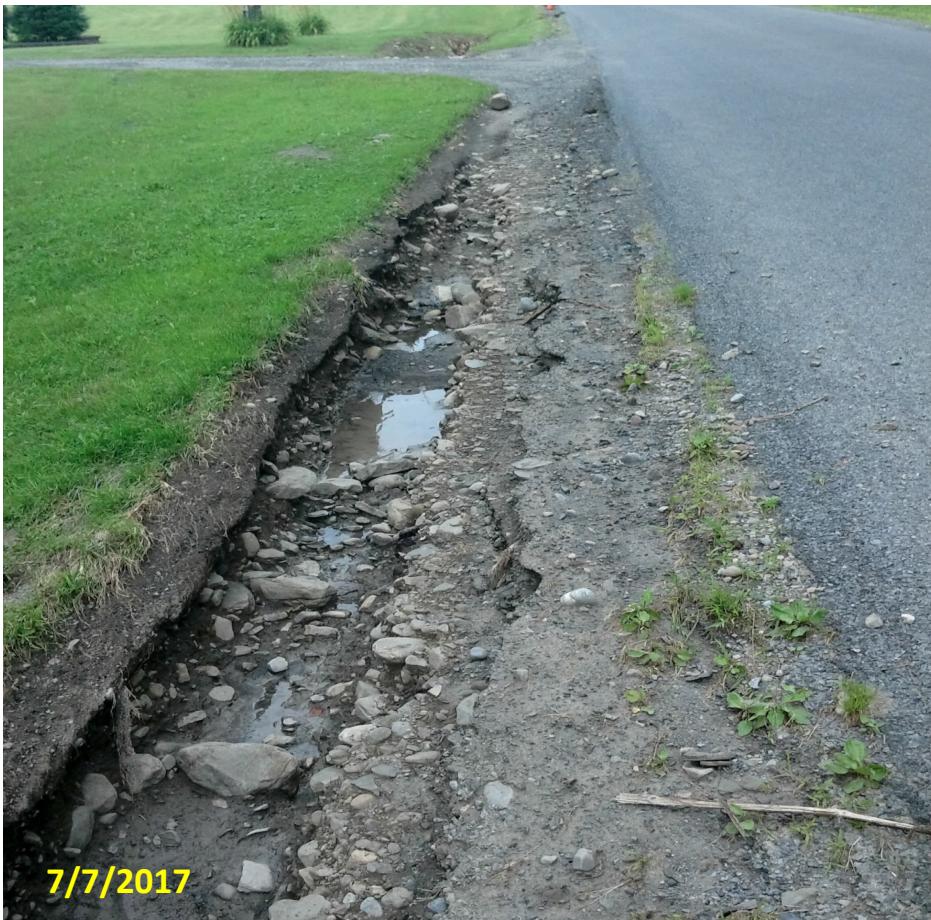
Map Identifier: Site 97
Sub-watershed: Owasco Inlet
Road Name: Main Road
Town: Locke
Road Jurisdiction: Town of Locke
Closest Intersection: Main Road/West Hill Road
Direct connection or proximity to a stream?: Yes
Percent Vegetation & Type: 0%
Level of Erodibility: High
Slope of Area: Moderate Grade
Length of Ditch: 550 ft
Management Recommended: Rock Armor
Resolvability: Difficult

Rank: High (Score = 55)
Estimated Cost: \$825

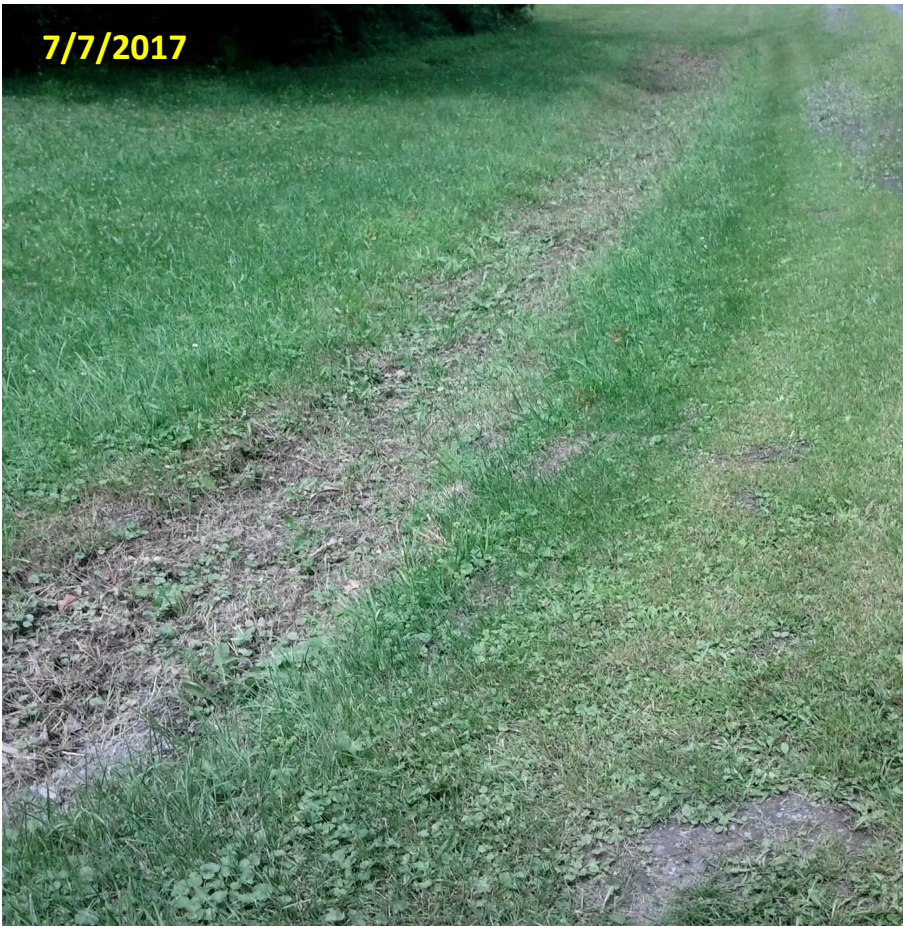
Map Identifier: Site 98
Sub-watershed: Owasco Inlet
Road Name: Main Road
Town: Locke
Road Jurisdiction: Town of Locke
Closest Intersection: Main Road/West Hill Road
Direct connection or proximity to a stream?: No
Percent Vegetation & Type: 50% Grasses
Level of Erodibility: Low
Slope of Area: Flat
Length of Ditch: 50 ft
Management Recommended: Hydroseeding
Resolvability: Simple

Rank: Low (Score = 17)
Estimated Cost: \$75

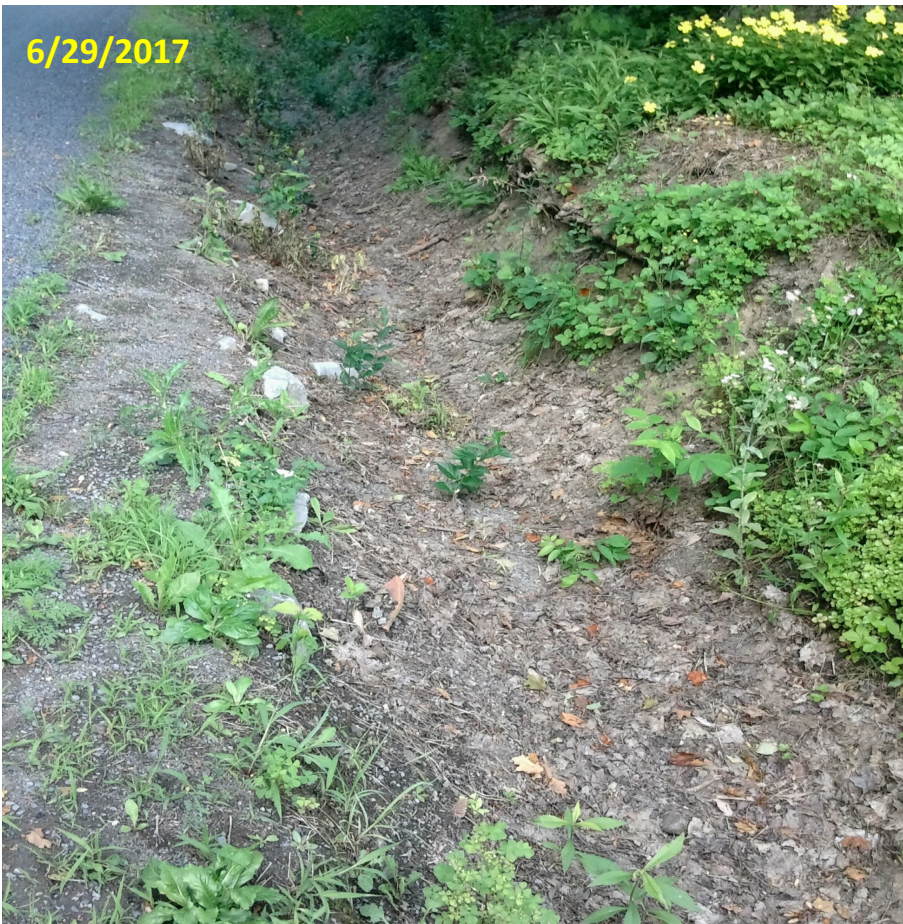
Map Identifier: Site 99
Sub-watershed: Owasco Inlet
Road Name: Erron Hill Road
Town: Locke
Road Jurisdiction: Town of Locke
Closest Intersection: Erron Hill Road/Mill Street
Direct connection or proximity to a stream?: Yes
Percent Vegetation & Type: 30% Grasses
Level of Erodibility: Low
Slope of Area: Steep Grade
Length of Ditch: 200 ft
Management Recommended: Hydroseeding
Resolvability: Moderate

Rank: Moderate (Score = 36)
Estimated Cost: \$300

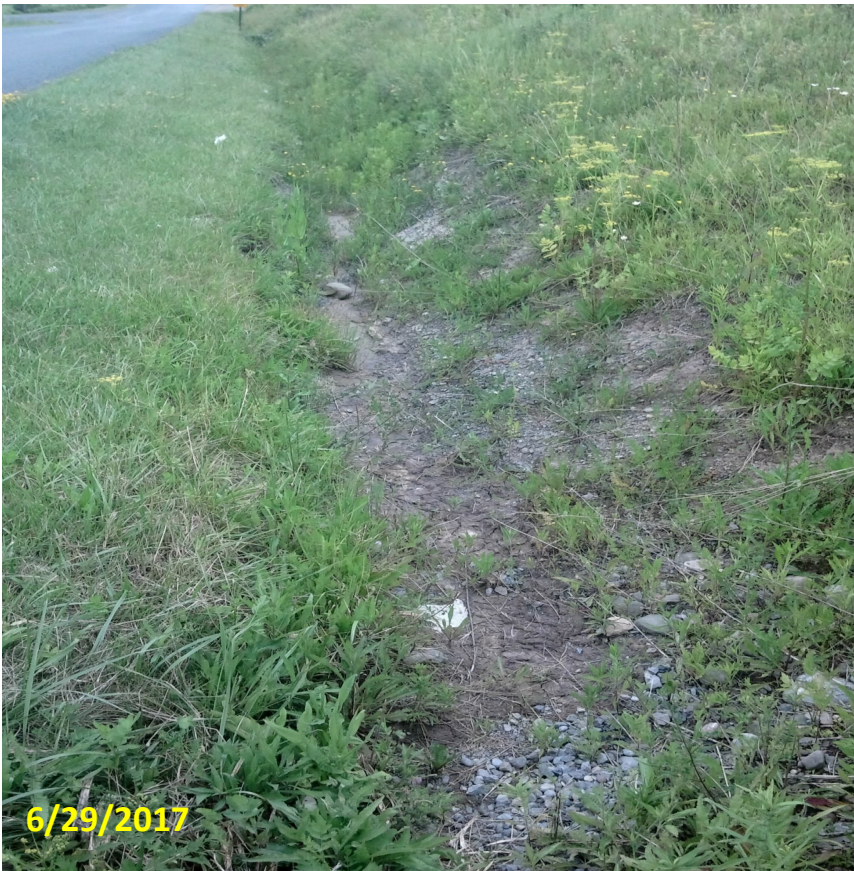
Map Identifier: Site 100
Sub-watershed: Owasco Inlet
Road Name: Cat Path Road
Town: Locke
Road Jurisdiction: Town of Locke
Closest Intersection: Cat Path Road /Cruthers Road
Direct connection or proximity to a stream?: Yes
Percent Vegetation & Type: 50% Grasses
Level of Erodibility: Moderate
Slope of Area: Moderate Grade
Length of Ditch: 300 ft
Management Recommended: Hydroseeding
Resolvability: Simple

Rank: High (Score = 40)
Estimated Cost: \$450

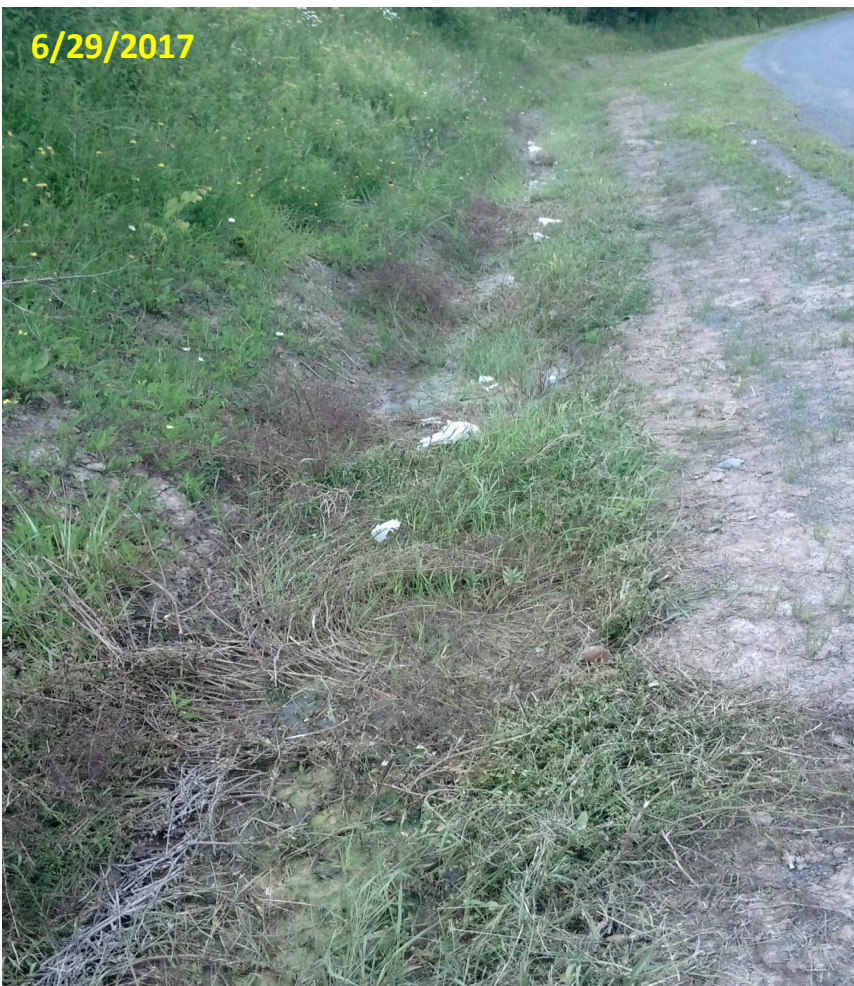
Map Identifier: Site 101
Sub-watershed: Owasco Inlet
Road Name: Cruthers Road
Town: Locke
Road Jurisdiction: Town of Locke
Closest Intersection: Cruthers Road/Cat Path Road
Direct connection or proximity to a stream?: No
Percent Vegetation & Type: 70% Grasses
Level of Erodibility: Moderate
Slope of Area: Moderate Grade
Length of Ditch: 400 ft
Management Recommended: Hydroseeding
Resolvability: Simple

Rank: Moderate (Score = 25)
Estimated Cost: \$600
Comments: Garbage and algae in ditch

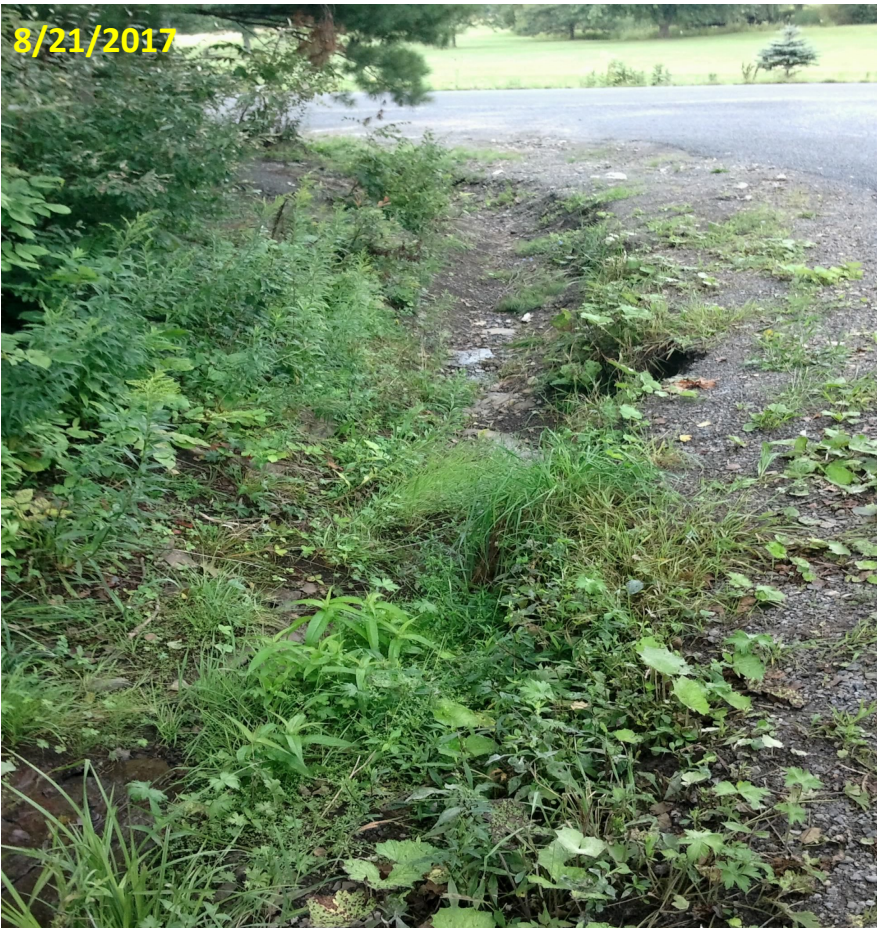
Map Identifier: Site 102
Sub-watershed: Owasco Inlet
Road Name: Cloverleaf Road
Town: Locke
Road Jurisdiction: Town of Locke
Closest Intersection: Cloverleaf Road/Toll Gate Hill Road
Direct connection or proximity to a stream?: No
Percent Vegetation & Type: 25% Woody Shrubs
Level of Erodibility: High
Slope of Area: Steep Grade
Length of Ditch: 200 ft
Management Recommended: Rock Armor
Resolvability: Moderate

Rank: High (Score = 45)
Estimated Cost: \$300

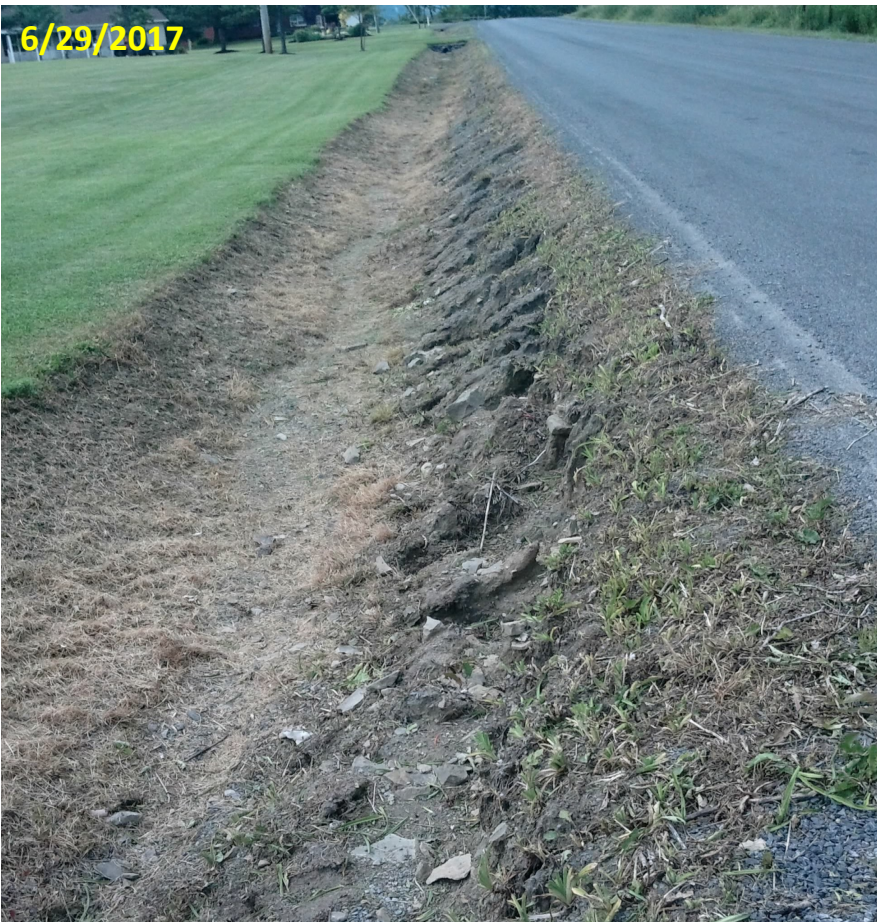
Map Identifier: Site 103
Sub-watershed: Owasco Inlet
Road Name: Toll Gate Hill Road
Town: Locke
Road Jurisdiction: Cayuga County Highway
Closest Intersection: Toll Gate Hill Road/Golf View Drive
Direct connection or proximity to a stream?: No
Percent Vegetation & Type: 5% Grasses
Level of Erodibility: Moderate
Slope of Area: Moderate Grade
Length of Ditch: 350 ft
Management Recommended: Hydroseeding
Resolvability: Difficult

Rank: Moderate (Score = 35)
Estimated Cost: \$525

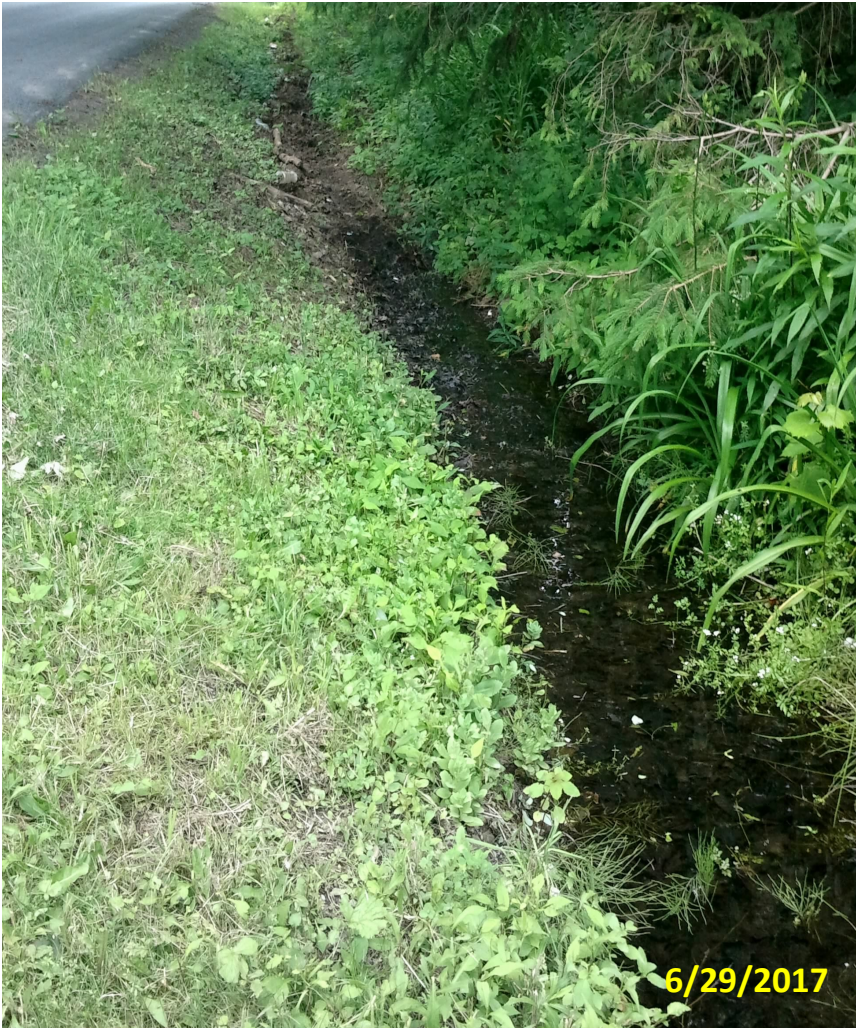
Map Identifier: Site 104
Sub-watershed: Owasco Inlet
Road Name: Toll Gate Hill Road
Town: Locke
Road Jurisdiction: Cayuga County Highway
Closest Intersection: Toll Gate Hill Road /Harris Hill Road
Direct connection or proximity to a stream?: No
Percent Vegetation & Type: 75% Grasses
Level of Erodibility: Moderate
Slope of Area: Moderate Grade
Length of Ditch: 150 ft
Management Recommended: Hydroseeding
Resolvability: Simple

Rank: Low (Score = 20)
Estimated Cost: \$225
Comments: Located within State Reforestation Lands

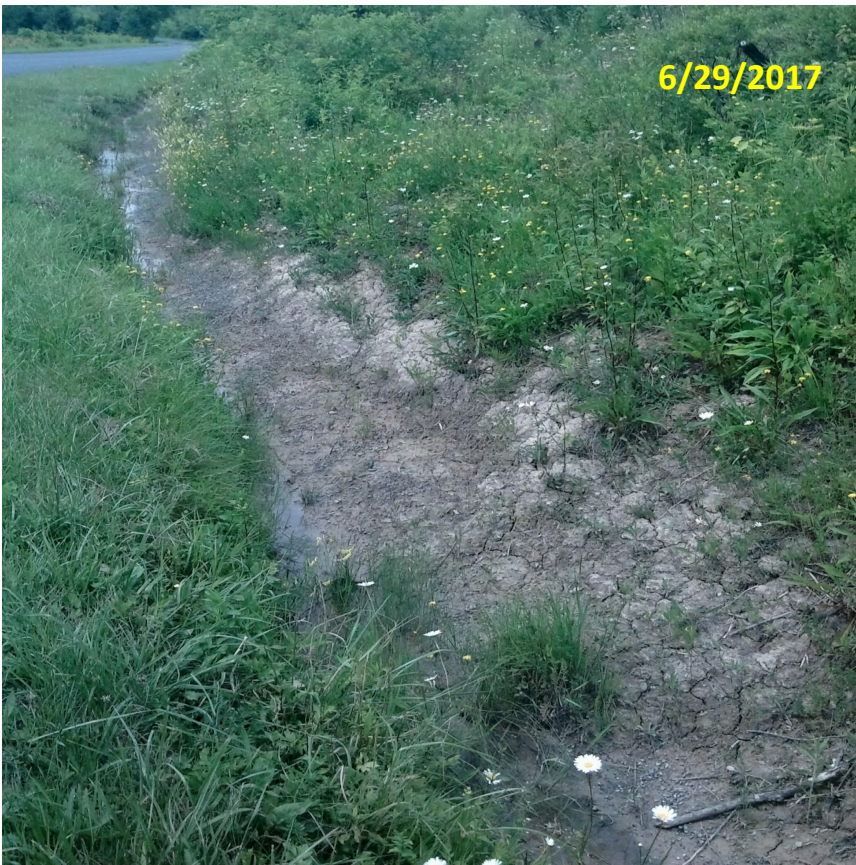
Map Identifier: Site 105
Sub-watershed: Owasco Inlet
Road Name: Old State Road
Town: Locke
Road Jurisdiction: Town of Locke
Closest Intersection: Old State Road/State Route 90
Direct connection or proximity to a stream?: Yes
Percent Vegetation & Type: 50% Grasses
Level of Erodibility: Moderate
Slope of Area: Moderate Grade
Length of Ditch: 450 ft
Management Recommended: Hydroseeding
Resolvability: Simple

Rank: High (Score = 45)
Estimated Cost: \$675

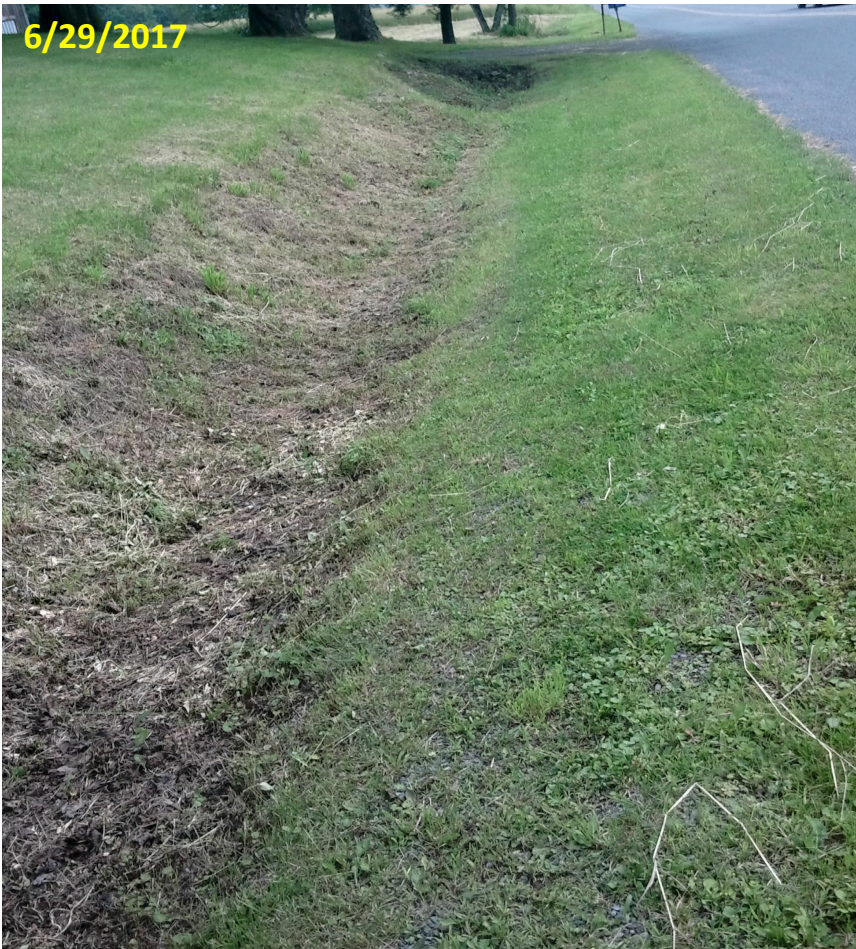
Map Identifier: Site 106
Sub-watershed: Owasco Inlet
Road Name: Chipmans Corners Road
Town: Locke
Road Jurisdiction: Cayuga County Highway
Closest Intersection: Chipmans Corners Road /State Route 90
Direct connection or proximity to a stream?: No
Percent Vegetation & Type: 50% Grasses
Level of Erodibility: Low
Slope of Area: Moderate Grade
Length of Ditch: 50 ft
Management Recommended: Hydroseeding
Resolvability: Simple

Rank: Moderate (Score = 21)
Estimated Cost: \$75

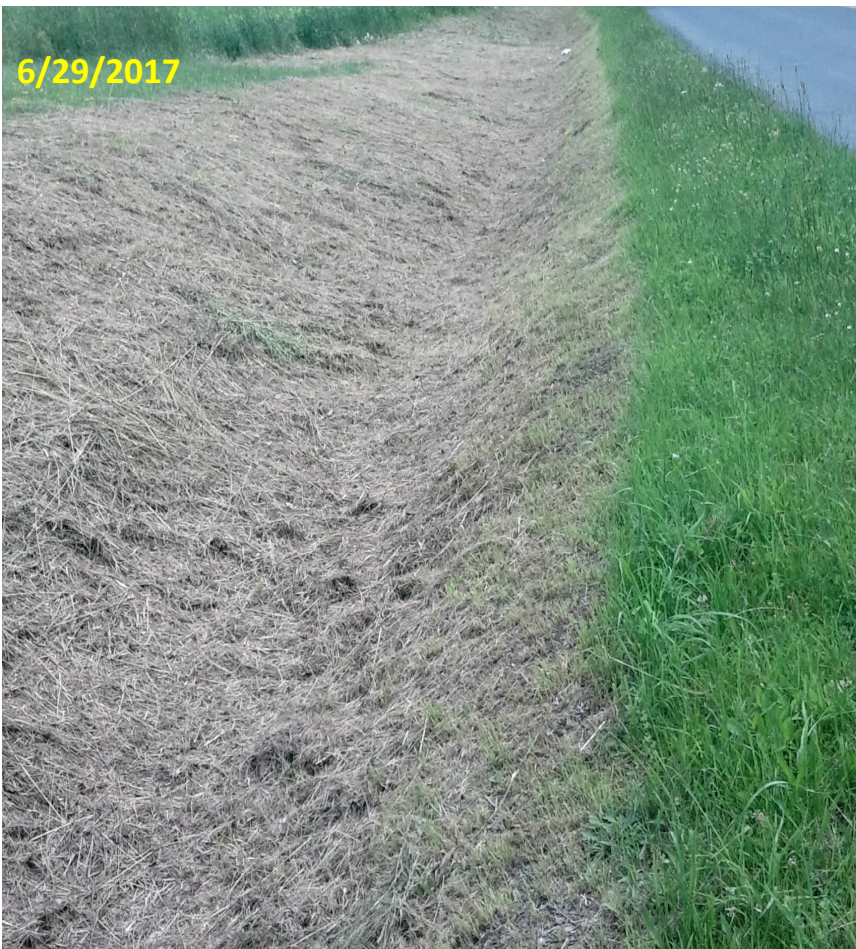
Map Identifier: Site 107
Sub-watershed: Owasco Inlet
Road Name: Chipmans Corners Road
Town: Locke
Road Jurisdiction: Cayuga County Highway
Closest Intersection: Chipmans Corners Road/Booth Road
Direct connection or proximity to a stream?: Yes
Percent Vegetation & Type: 50% Grasses
Level of Erodibility: Low
Slope of Area: Moderate Grade
Length of Ditch: 300 ft
Management Recommended: Hydroseeding
Resolvability: Simple

Rank: Moderate (Score = 36)
Estimated Cost: \$450
