# Owasco Lake Watershed 2017 Roadside Ditch Assessment

# Road Ditch Assessment Sites in the Owasco Lake Watershed (Summer 2017)

# Road Ditch Assessment Sites in Fleming (Cayuga County)

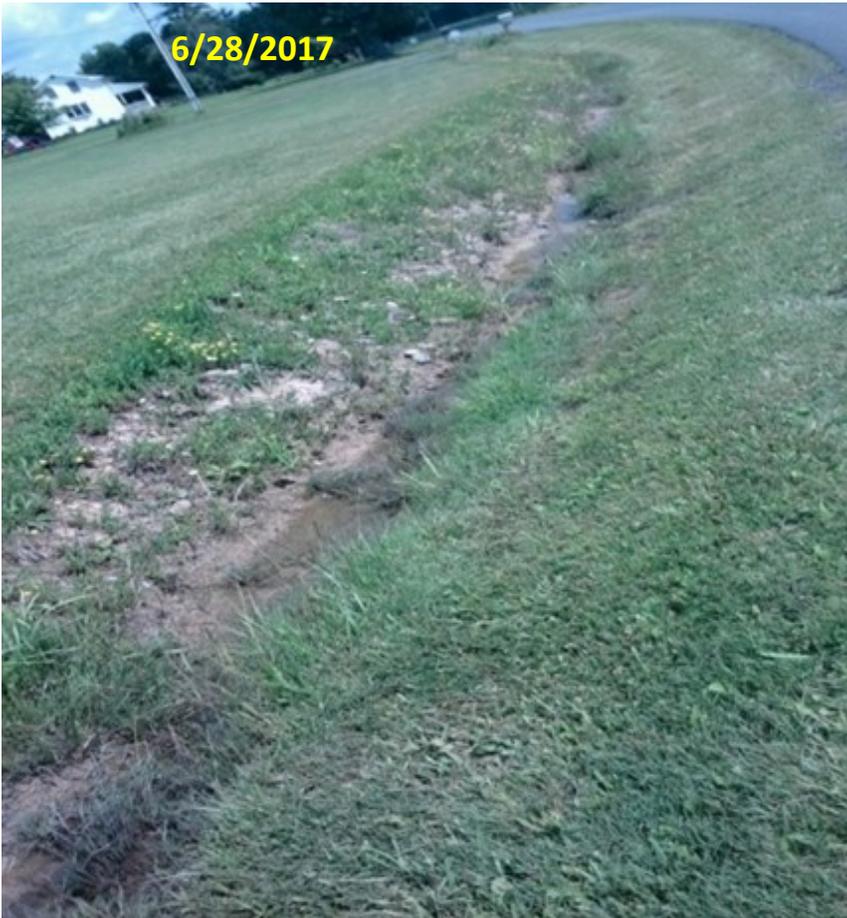
**Map Identifier:** Site 1  
**Sub-watershed:** Veness Brook  
**Road Name:** Mobbs Road  
**Town:** Fleming  
**Road Jurisdiction:** Town of Fleming  
**Closest Intersection:** Mobbs Road/  
Silver Street Road  
**Direct connection or proximity to a stream?:** No  
**Percent Vegetation & Type:** 60%  
Grasses  
**Level of Erodibility:** Moderate  
**Slope of Area:** Moderate Grade  
**Length of Ditch:** 200 ft  
**Management Recommended:**  
Hydroseeding  
**Resolvability:** Simple

**Rank: Low (Score = 20)**  
**Estimated Cost: \$300**

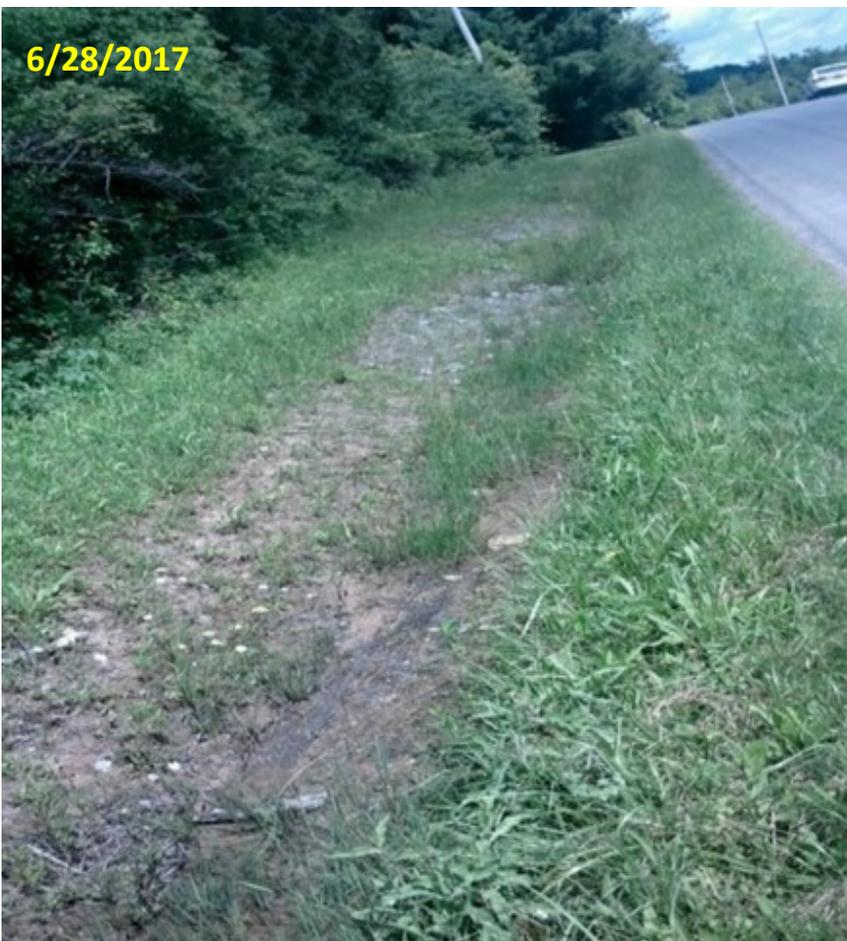
**Map Identifier:** Site 2  
**Sub-watershed:** Veness Brook  
**Road Name:** Mobbs Road  
**Town:** Fleming  
**Road Jurisdiction:** Town of Fleming  
**Closest Intersection:** Mobbs Road/  
West Lake Road  
**Direct connection or proximity to a stream?:** No  
**Percent Vegetation & Type:** 50%  
Grasses  
**Level of Erodibility:** Low  
**Slope of Area:** Moderate Grade  
**Length of Ditch:** 150 ft  
**Management Recommended:**  
Hydroseeding  
**Resolvability:** Simple

**Rank: Moderate (Score = 21)**  
**Estimated Cost: \$225**  
**Comments:** rocky soil, some  
garbage in ditch

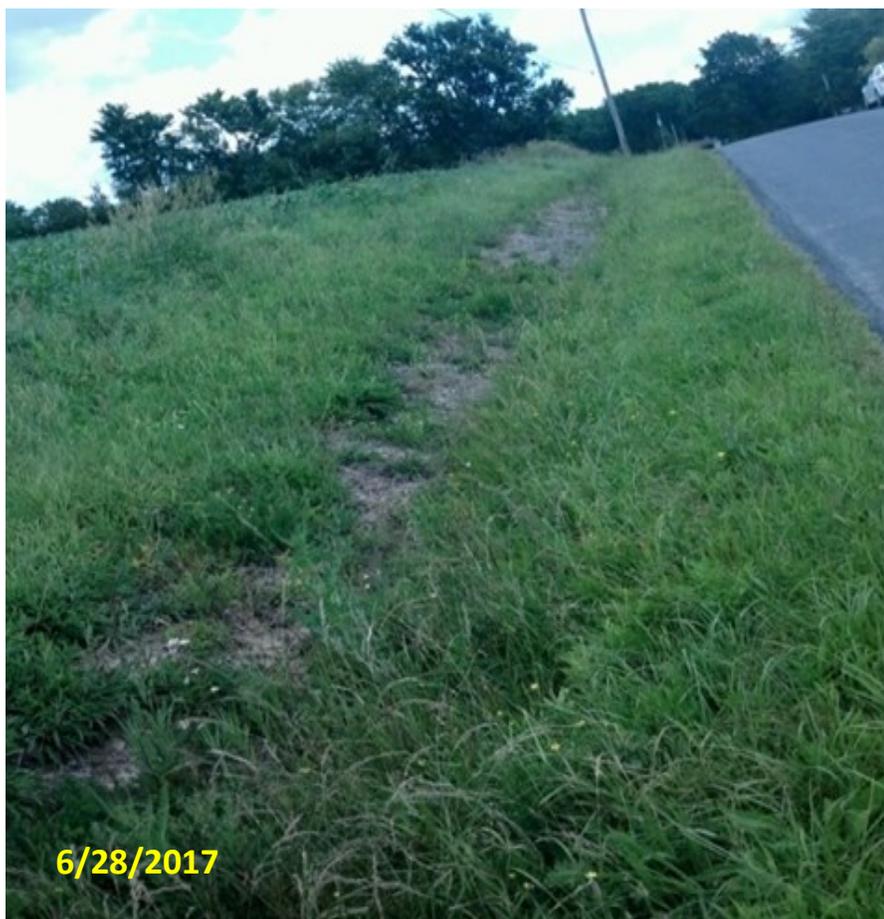
**Map Identifier:** Site 3  
**Sub-watershed:** Veness Brook  
**Road Name:** Mobbs Road  
**Town:** Fleming  
**Road Jurisdiction:** Town of Fleming  
**Closest Intersection:** Mobbs Road/West Lake Road  
**Direct connection or proximity to a stream?:** No  
**Percent Vegetation & Type:** 50% Grasses  
**Level of Erodibility:** Low  
**Slope of Area:** Moderate Grade  
**Length of Ditch:** 300 ft  
**Management Recommended:** Hydroseeding  
**Resolvability:** Simple

**Rank: Moderate (Score = 26)**  
**Estimated Cost: \$450**

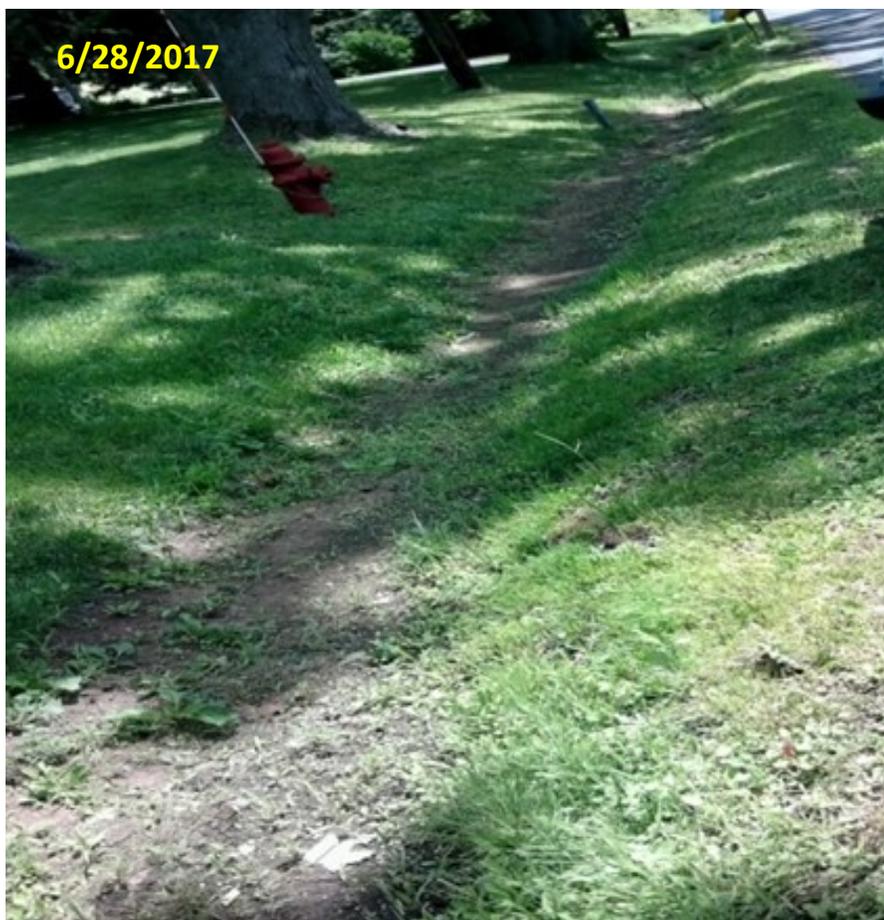
**Map Identifier:** Site 4  
**Sub-Watershed:** Veness Brook  
**Road Name:** Mobbs Road  
**Town:** Fleming  
**Road Jurisdiction:** Town of Fleming  
**Closest Intersection:** Mobbs Road/West Lake Road  
**Direct connection or proximity to a stream?:** No  
**Percent Vegetation & Type:** 50% Grasses  
**Level of Erodibility:** Moderate  
**Slope of Area:** Flat  
**Length of Ditch:** 300 ft  
**Management Recommended:** Hydroseeding  
**Resolvability:** Simple

**Rank: Moderate (Score = 26)**  
**Estimated Cost: \$450**

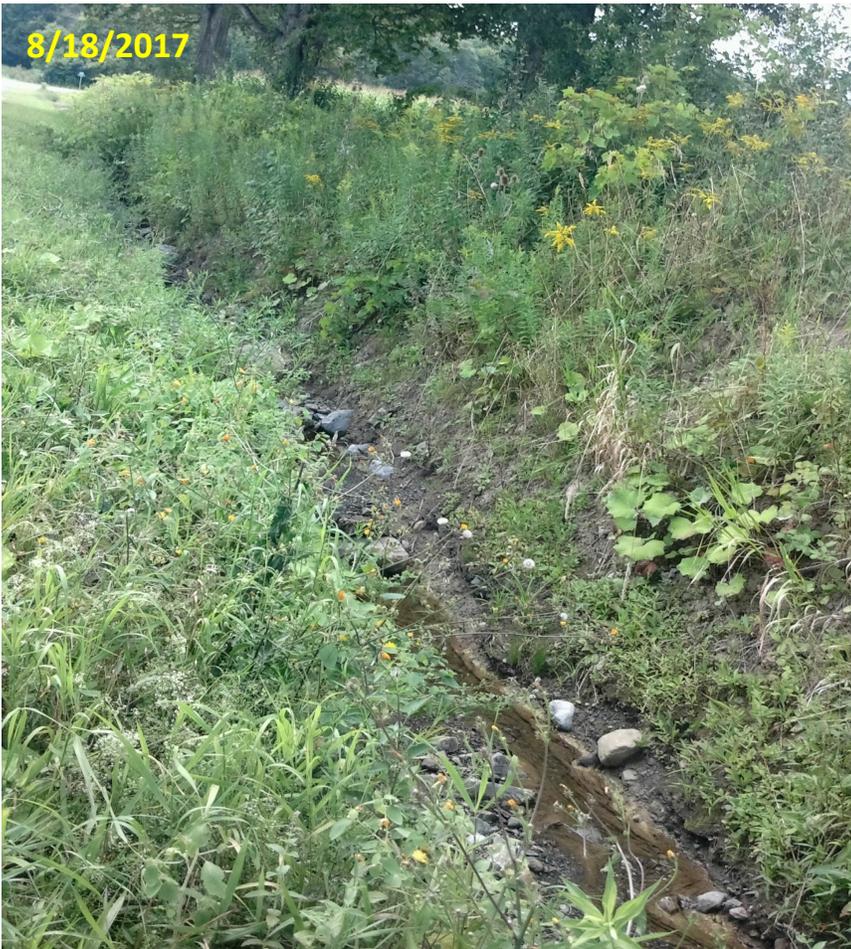
**Map Identifier:** Site 5  
**Sub-watershed:** Unknown  
**Road Name:** Wyckoff Road  
**Town:** Fleming  
**Road Jurisdiction:** Cayuga County Highway  
**Closest Intersection:** Wyckoff Road/Town Line Road  
**Direct connection or proximity to a stream?:** No  
**Percent Vegetation & Type:** 70% Grasses  
**Level of Erodibility:** Low  
**Slope of Area:** Moderate Grade  
**Length of Ditch:** 500 ft  
**Management Recommended:** Hydroseeding  
**Resolvability:** Simple

**Rank: Moderate (Score = 26)**  
**Estimated Cost: \$750**
