Owasco Lake Watershed 2017 Roadside Ditch Assessment

Road Ditch Assessment Sites in Owasco (Cayuga County)

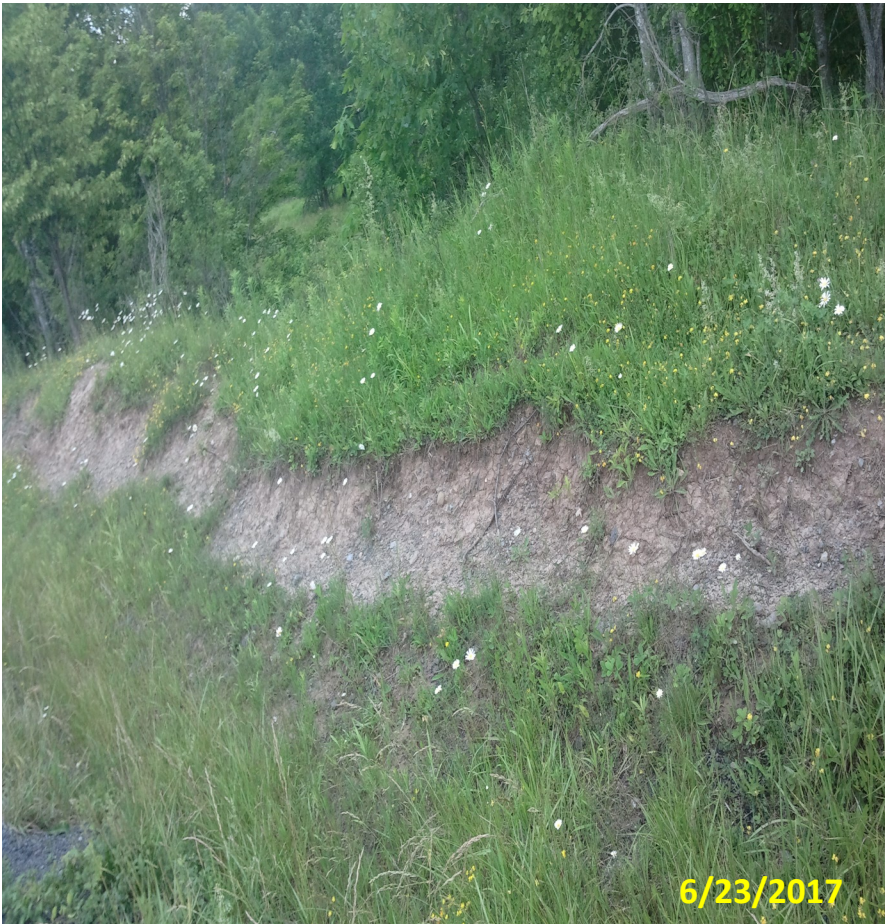
Map Identifier: Site 17
Sub-watershed: Sucker Brook
Road Name: Byrne Road
Town: Owasco
Road Jurisdiction: Town of Owasco
Closest Intersection: Byrne Road/ Melrose Road
Direct connection or proximity to a stream?: Yes
Percent Vegetation & Type: 60% Grasses
Level of Erodibility: Low
Slope of Area: Flat
Length of Ditch: 100 ft
Management Recommended: Hydroseeding
Resolvability: Simple

Rank: Moderate (Score = 22)
Estimated Cost: \$150

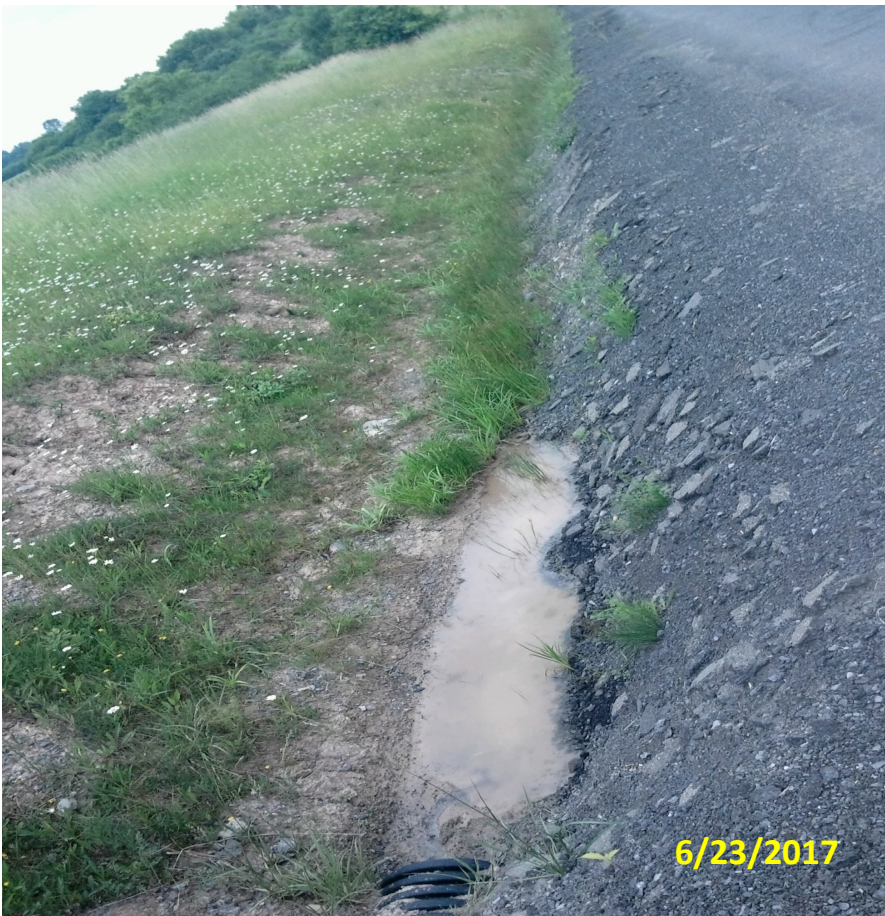
Map Identifier: Site 18
Sub-watershed: Sucker Brook
Road Name: Byrne Road
Town: Owasco
Road Jurisdiction: Town of Owasco
Closest Intersection: Byrne Road/ Melrose Road
Direct connection or proximity to a stream?: No
Percent Vegetation & Type: 70% Grasses
Level of Erodibility: Low
Slope of Area: Moderate Grade
Length of Ditch: 600 ft
Management Recommended: Hydroseeding
Resolvability: Moderate

Rank: Moderate (Score = 26)
Estimated Cost: \$900

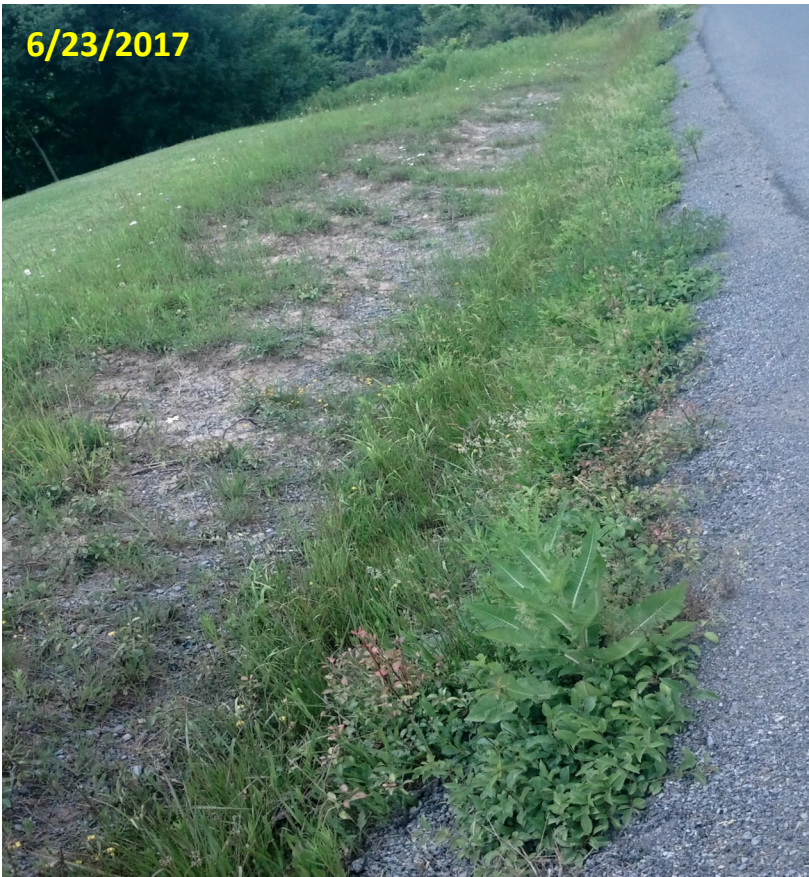
Map Identifier: Site 19
Sub-watershed: Sucker Brook
Road Name: Byrne Road
Town: Owasco
Road Jurisdiction: Town of Owasco
Closest Intersection: Byrne Road/
Melrose Road
Direct connection or proximity to a stream?: Yes
Percent Vegetation & Type: 60%
Grasses
Level of Erodibility: Low
Slope of Area: Moderate Grade
Length of Ditch: 100 ft
Management Recommended:
Hydroseeding
Resolvability: Simple

Rank: Moderate (Score = 26)
Estimated Cost: \$150

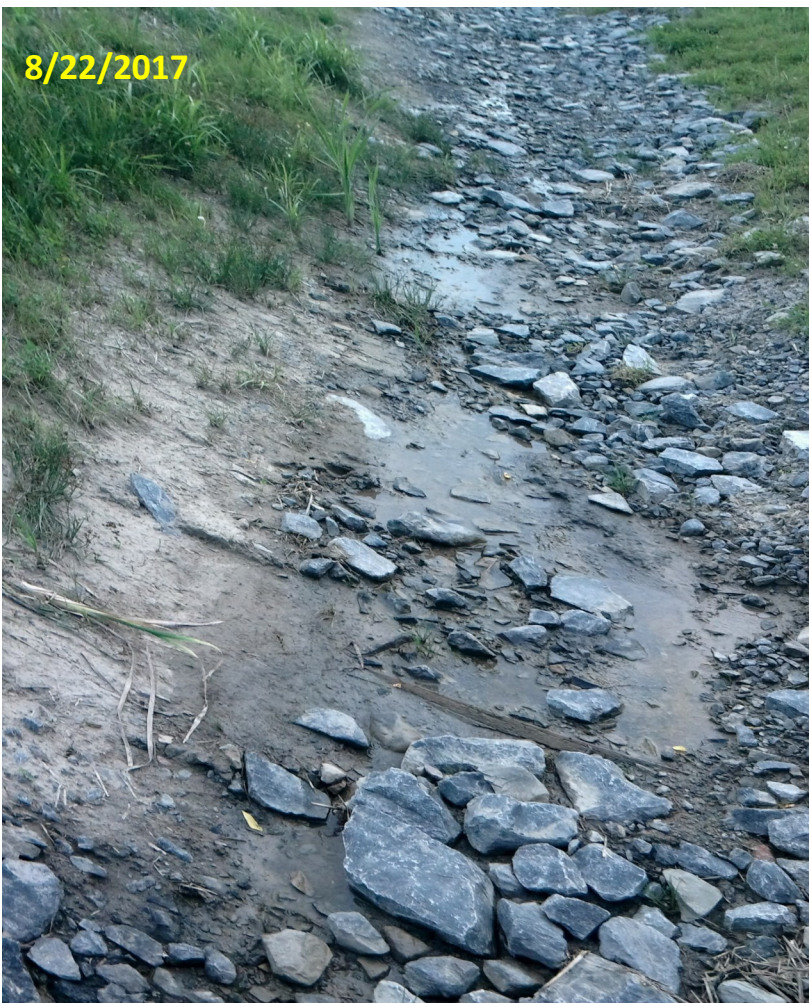
Map Identifier: Site 20
Sub-watershed: Sucker Brook
Road Name: Melrose Road
Town: Owasco
Road Jurisdiction: Cayuga County
Highway
Closest Intersection: Melrose Road/
Byrne Road
Direct connection or proximity to a stream?: Yes
Percent Vegetation & Type: 50%
Grasses
Level of Erodibility: Moderate
Slope of Area: Steep Grade
Length of Ditch: 800 ft
Management Recommended:
Hydroseeding
Resolvability: Moderate

Rank: High (Score = 50)
Estimated Cost: \$1,200
Comments: Check dams present at
site before ditch assessment

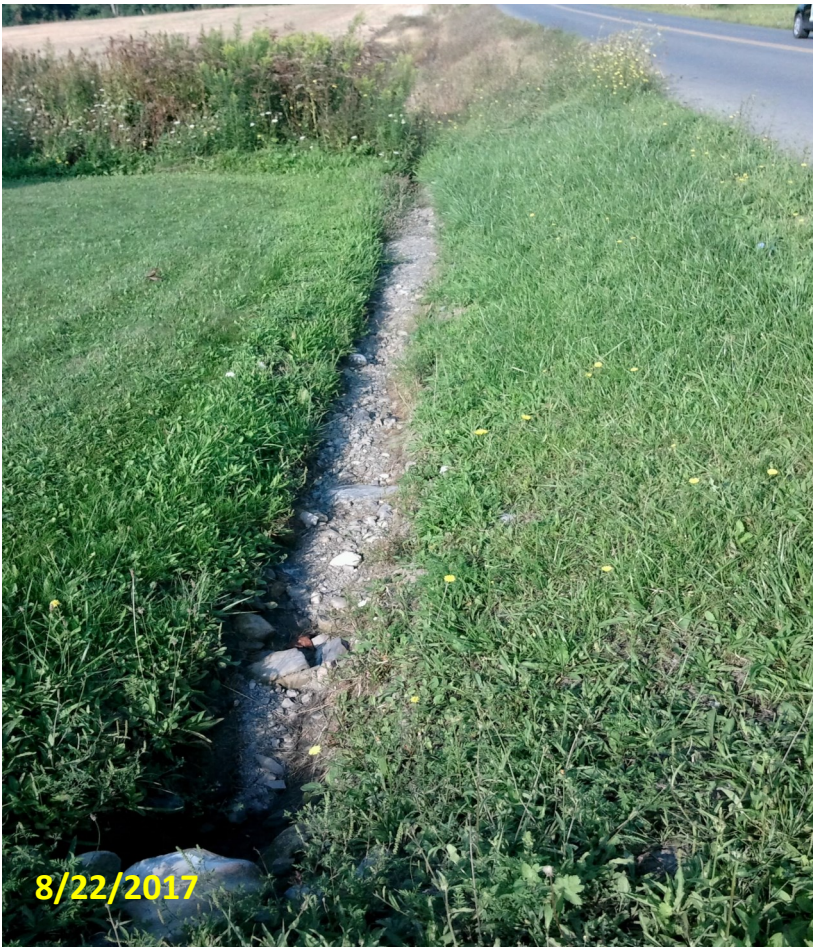
Map Identifier: Site 21
Sub-watershed: Sucker Brook
Road Name: Melrose Road
Town: Owasco
Road Jurisdiction: Cayuga County Highway
Closest Intersection: Melrose Road/ Beech Road
Direct connection or proximity to a stream?: Yes
Percent Vegetation & Type: 75% Grasses
Level of Erodibility: Moderate
Slope of Area: Moderate Grade
Length of Ditch: 450 ft
Management Recommended: Hydroseeding
Resolvability: Moderate

Rank: High (Score = 40)
Estimated Cost: \$675
Comments: some garbage in ditch

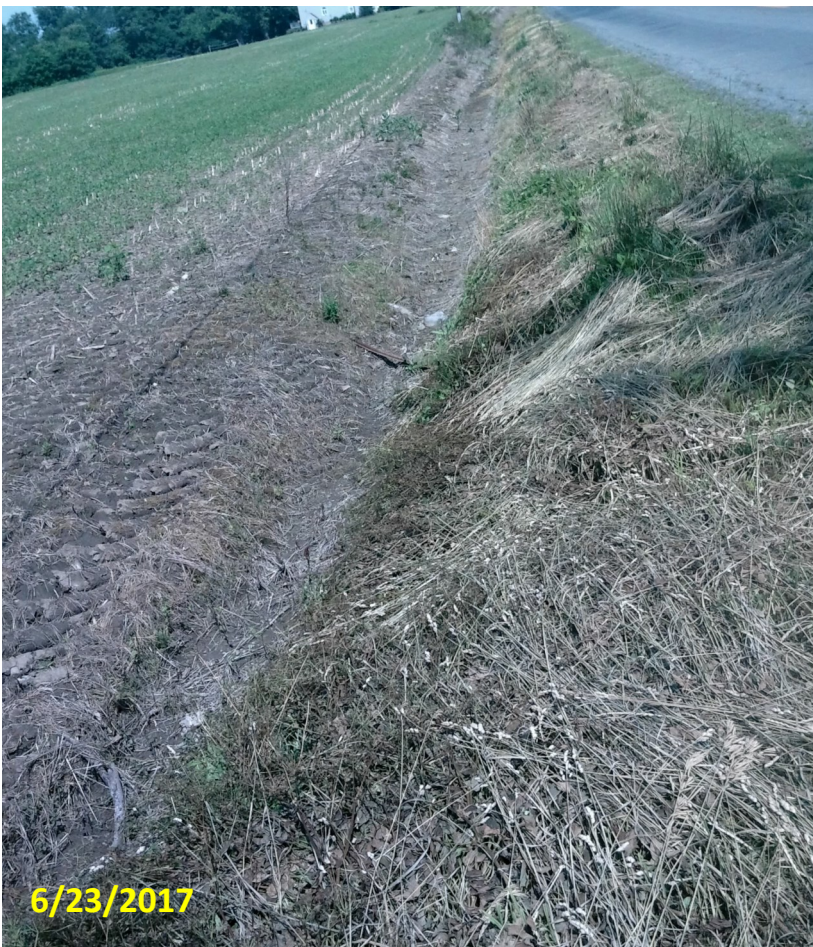
Map Identifier: Site 22
Sub-watershed: Sucker Brook
Road Name: Melrose Road
Town: Owasco
Road Jurisdiction: Cayuga County Highway
Closest Intersection: Melrose Road/ Beech Road
Direct connection or proximity to a stream?: No
Percent Vegetation & Type: 40% Grasses
Level of Erodibility: Moderate
Slope of Area: Flat
Length of Ditch: 600 ft
Management Recommended: Hydroseeding
Resolvability: Simple

Rank: Moderate (Score = 31)
Estimated Cost: \$900
Comments: Garbage in ditch

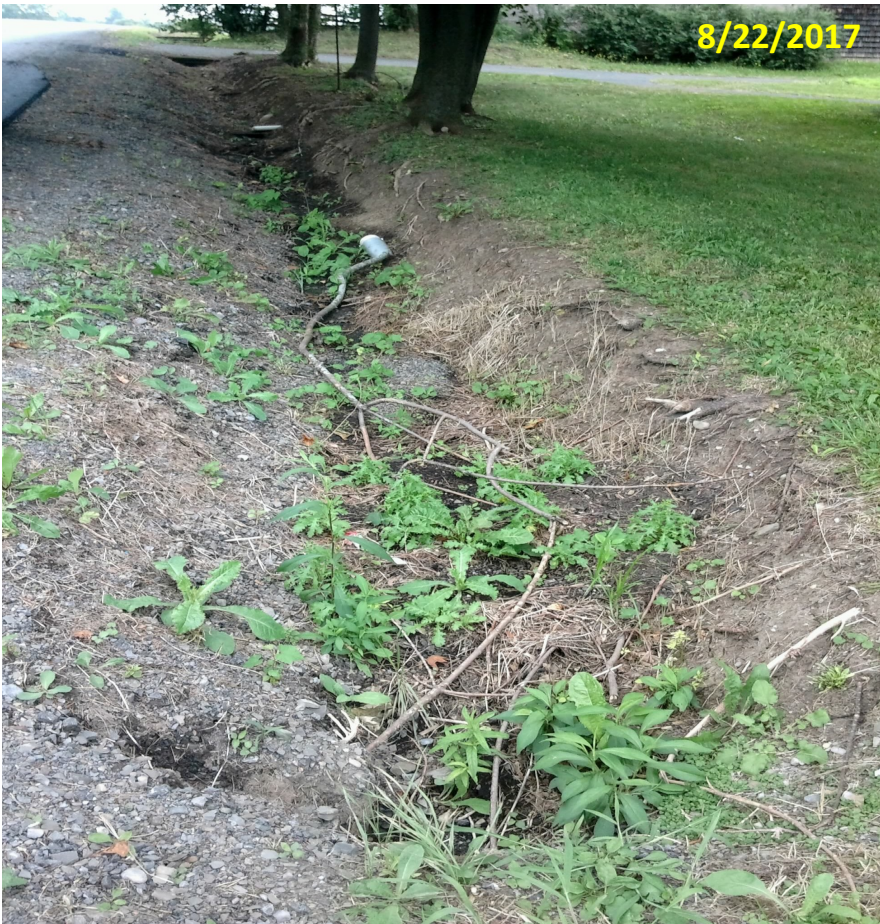
Map Identifier: Site 23
Sub-watershed: Sucker Brook
Road Name: Baptist Corners Road
Town: Owasco
Road Jurisdiction: Cayuga County Highway
Closest Intersection: Baptist Corners Road/North Road
Direct connection or proximity to a stream?: No
Percent Vegetation & Type: 10% Grasses
Level of Erodibility: Moderate
Slope of Area: Moderate Grade
Length of Ditch: 150 ft
Management Recommended: Hydroseeding
Resolvability: Moderate

Rank: Moderate (Score = 30)
Estimated Cost: \$225

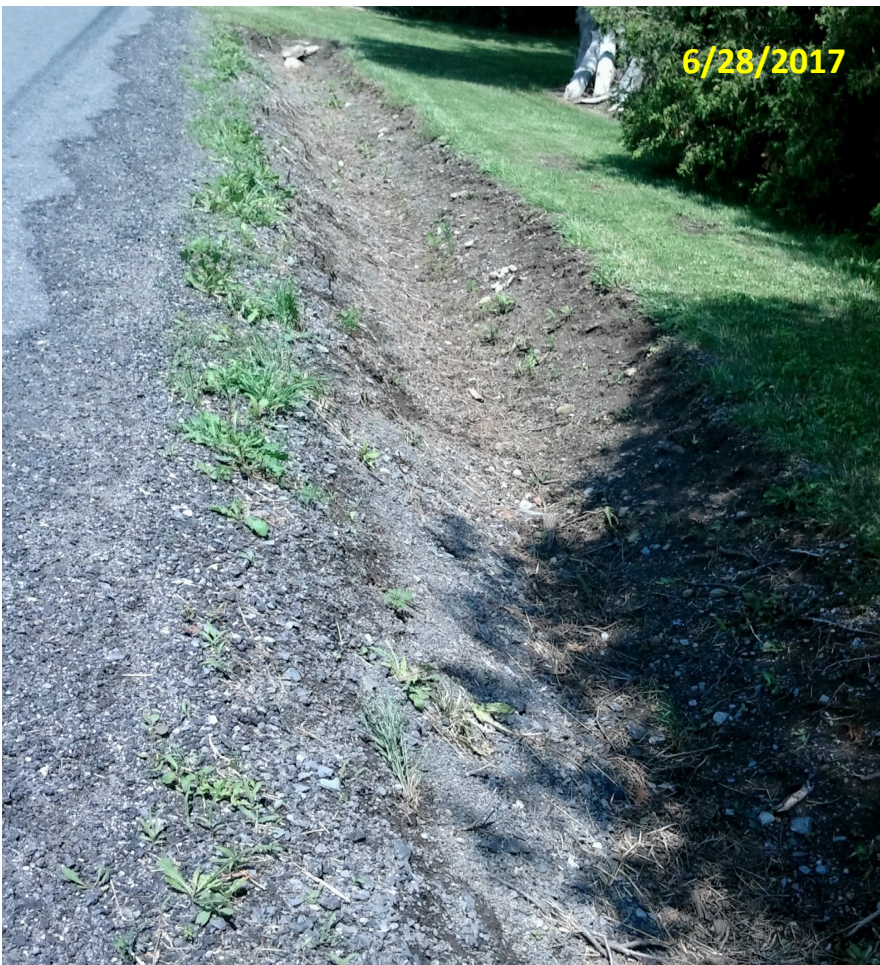
Map Identifier: Site 24
Sub-watershed: Sucker Brook
Road Name: Town Hall Road
Town: Owasco
Road Jurisdiction: Town of Owasco
Closest Intersection: Town Hall Road/Giza Road
Direct connection or proximity to a stream?: No
Percent Vegetation & Type: 5% Grasses
Level of Erodibility: Low
Slope of Area: Flat
Length of Ditch: 50 ft
Management Recommended: Hydroseeding
Resolvability: Simple

Rank: Moderate (Score = 22)
Estimated Cost: \$75

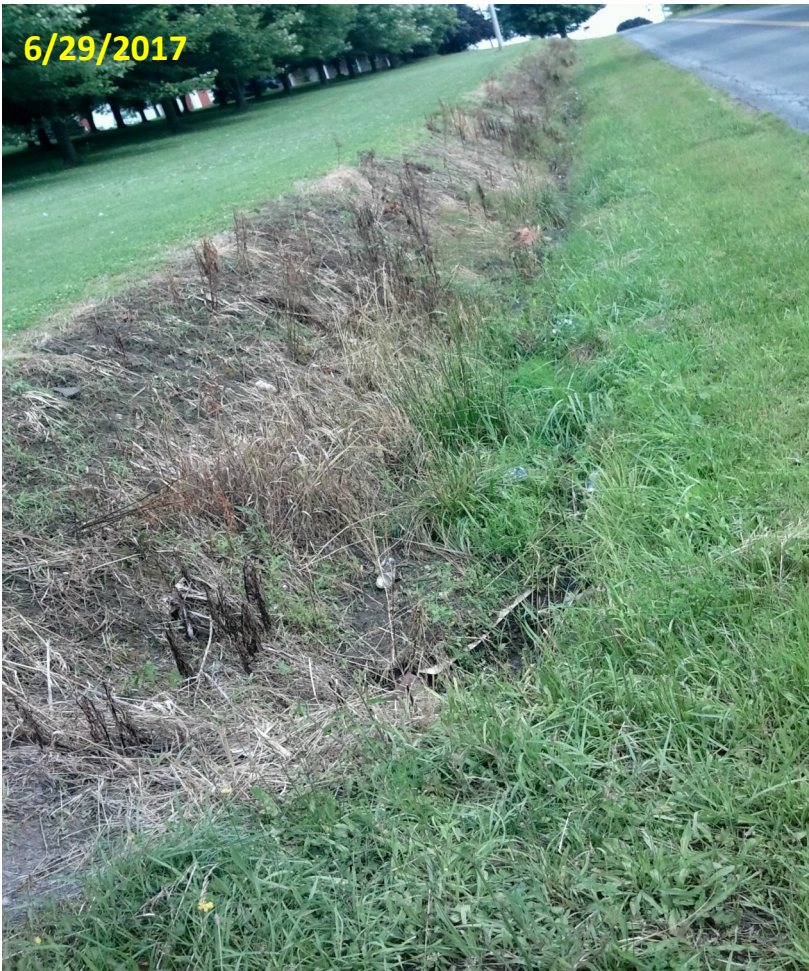
Map Identifier: Site 25
Sub-watershed: Dutch Hollow Brook
Road Name: North Road
Town: Owasco
Road Jurisdiction: Cayuga County Highway
Closest Intersection: North Road/Barski Road
Direct connection or proximity to a stream?: Yes
Percent Vegetation & Type: 40% Grasses
Level of Erodibility: Moderate
Slope of Area: Moderate Grade
Length of Ditch: 600 ft
Management Recommended: Hydroseeding
Resolvability: Simple

Rank: High (Score = 45)
Estimated Cost: \$900
Comments: Garbage in ditch, culvert in deteriorating condition

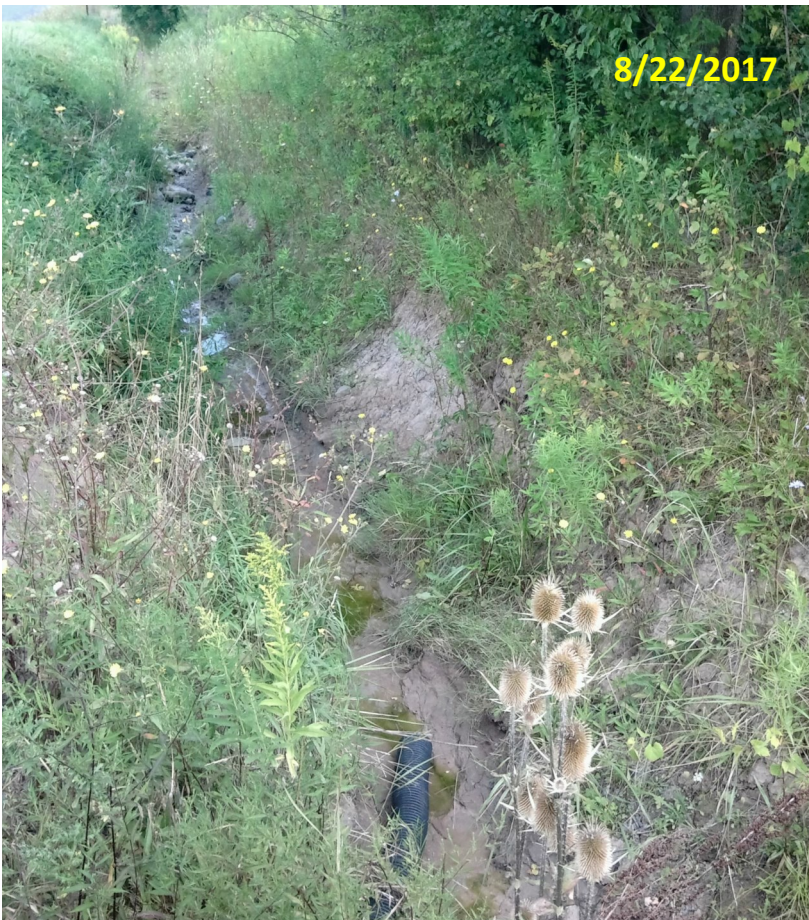
Map Identifier: Site 26
Sub-watershed: Dutch Hollow Brook
Road Name: North Road
Town: Owasco
Road Jurisdiction: Cayuga County Highway
Closest Intersection: North Road/Murphy's Way
Direct connection or proximity to a stream?: Yes
Percent Vegetation & Type: 50% Grasses
Level of Erodibility: Moderate
Slope of Area: Moderate Grade
Length of Ditch: 250 ft
Management Recommended: Hydroseeding
Resolvability: Moderate

Rank: High (Score = 40)
Estimated Cost: \$375

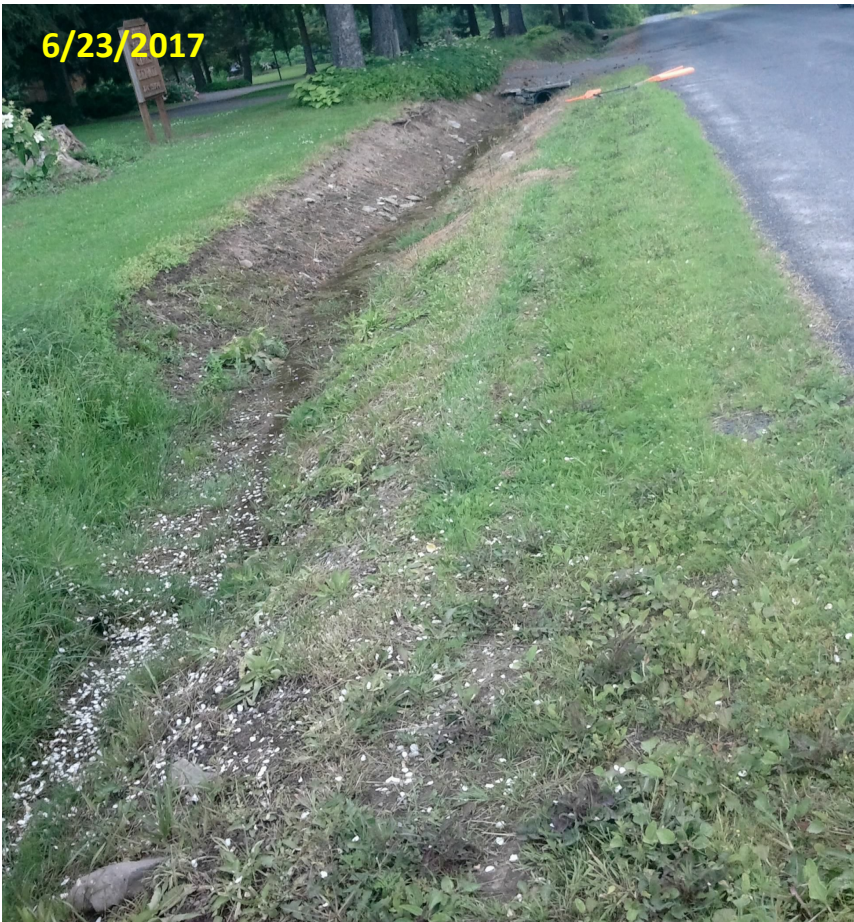
Map Identifier: Site 27
Sub-watershed: Dutch Hollow Brook
Road Name: Martin Road
Town: Owasco
Road Jurisdiction: Town of Owasco
Closest Intersection: Martin Road/Honeysuckle Road
Direct connection or proximity to a stream?: Yes
Percent Vegetation & Type: 30% Grasses
Level of Erodibility: Moderate
Slope of Area: Moderate Grade
Length of Ditch: 250 ft
Management Recommended: Hydroseeding
Resolvability: Simple

Rank: High (Score = 40)
Estimated Cost: \$375

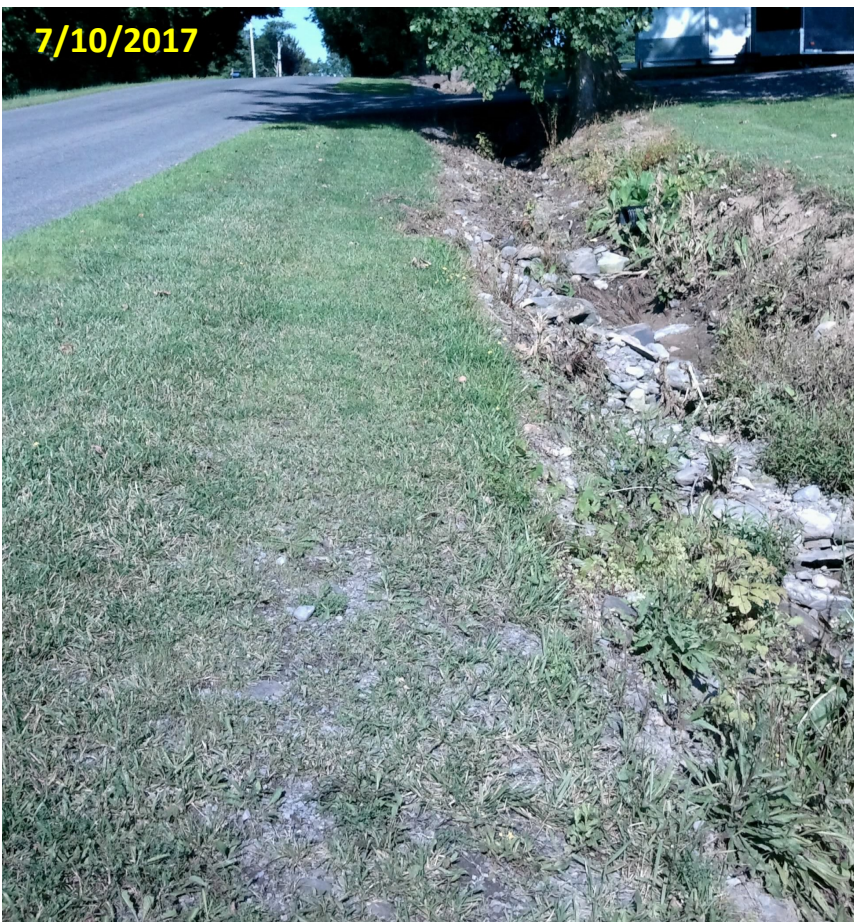
Map Identifier: Site 28
Sub-watershed: Dutch Hollow Brook
Road Name: Honeysuckle Road
Town: Owasco
Road Jurisdiction: Town of Owasco
Closest Intersection: Honeysuckle Road/Martin Road
Direct connection or proximity to a stream?: Yes
Percent Vegetation & Type: 30% Grasses
Level of Erodibility: Moderate
Slope of Area: Moderate Grade
Length of Ditch: 350 ft
Management Recommended: Hydroseeding
Resolvability: Moderate

Rank: High (Score = 40)
Estimated Cost: \$525

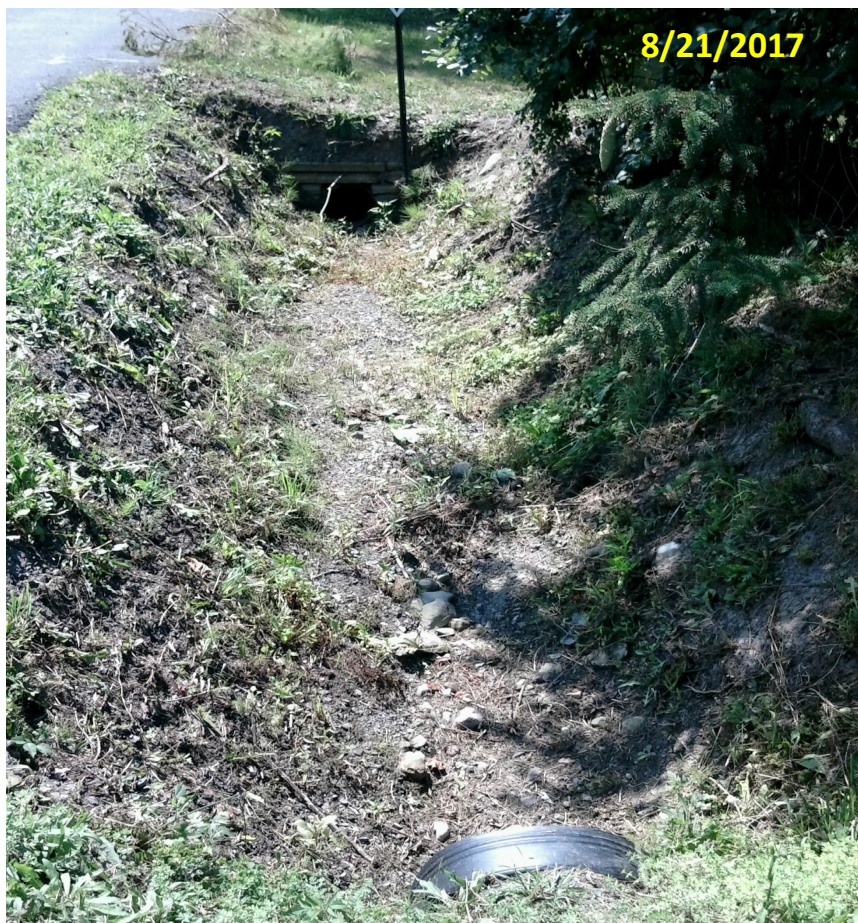
Map Identifier: Site 29
Sub-watershed: Unknown
Road Name: Rockefeller Road
Town: Owasco
Road Jurisdiction: Cayuga County Highway
Closest Intersection: Rockefeller Road/Gleason Drive
Direct connection or proximity to a stream?: No
Percent Vegetation & Type: 50% Grasses
Level of Erodibility: Low
Slope of Area: Flat
Length of Ditch: 50 ft
Management Recommended: Hydroseeding
Resolvability: Simple

Rank: Low (Score = 17)
Estimated Cost: \$75

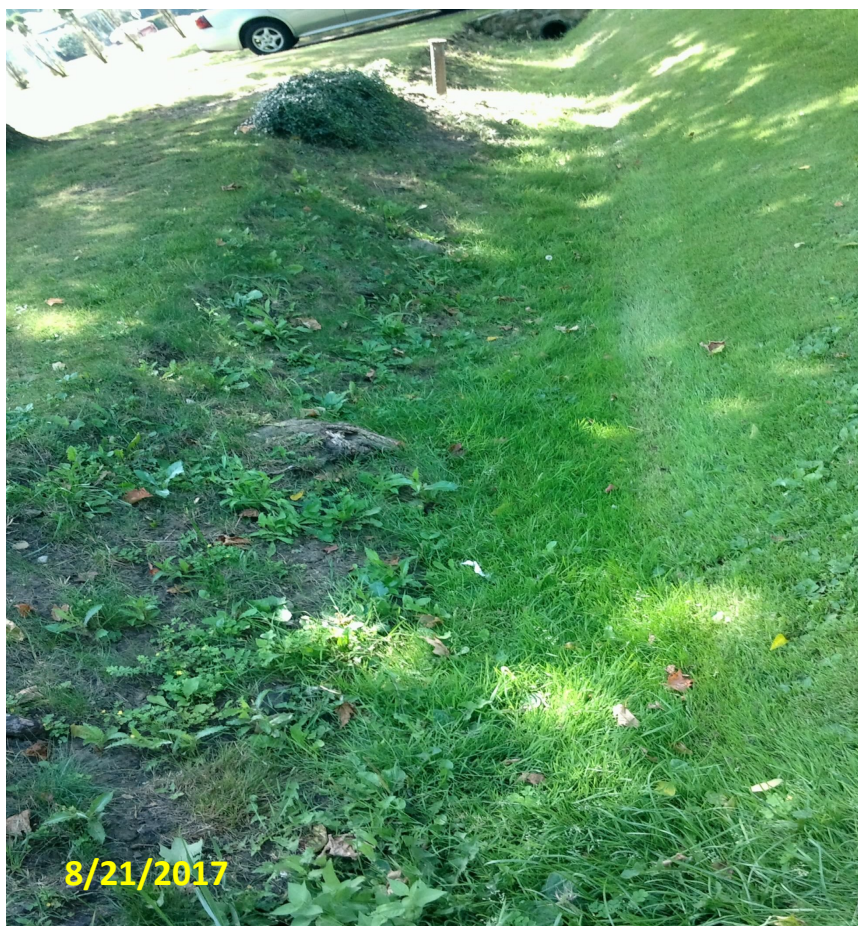
Map Identifier: Site 30
Sub-watershed: Unknown
Road Name: Rockefeller Road
Town: Owasco
Road Jurisdiction: Cayuga County Highway
Closest Intersection: Rockefeller Road/Denman Cove
Direct connection or proximity to a stream?: No
Percent Vegetation & Type: 80% Grasses
Level of Erodibility: Low
Slope of Area: Moderate Grade
Length of Ditch: 200 ft
Management Recommended: Hydroseeding
Resolvability: Simple

Rank: Low (Score = 17)
Estimated Cost: \$300

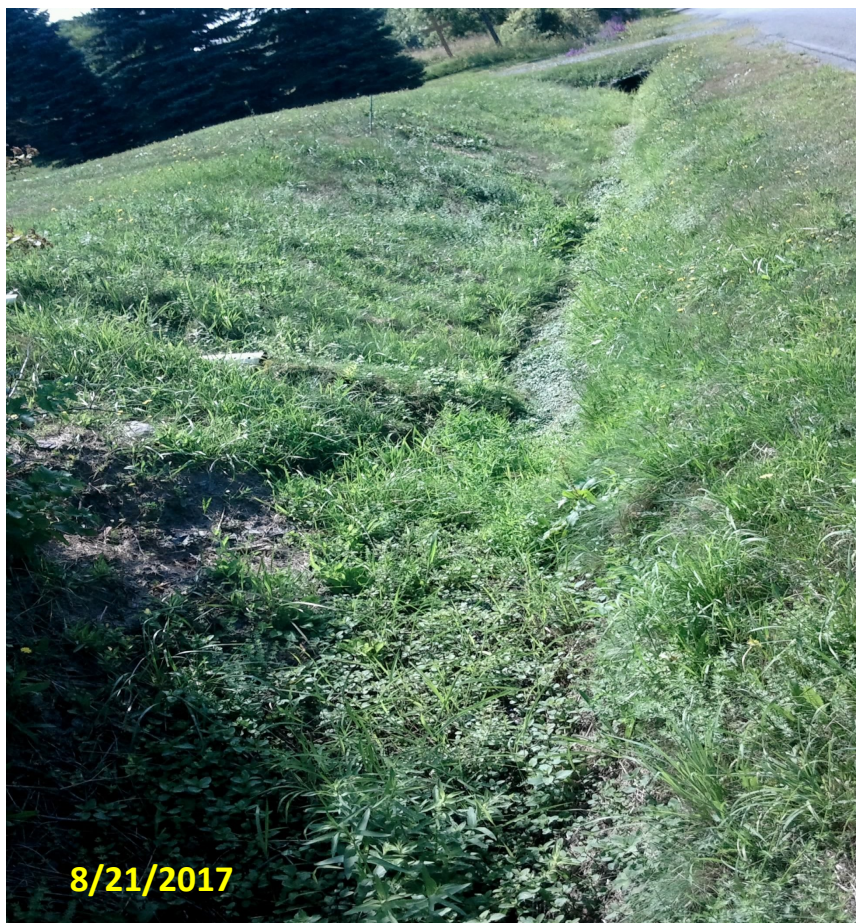
Map Identifier: Site 31
Sub-watershed: Unknown
Road Name: Rockefeller Road
Town: Owasco
Road Jurisdiction: Cayuga County Highway
Closest Intersection: Rockefeller Road/Fire Lane 12A
Direct connection or proximity to a stream?: No
Percent Vegetation & Type: 80% Grasses
Level of Erodibility: Low
Slope of Area: Moderate Grade
Length of Ditch: 50 ft
Management Recommended: Hydroseeding
Resolvability: Simple

Rank: Low (Score = 17)
Estimated Cost: \$75

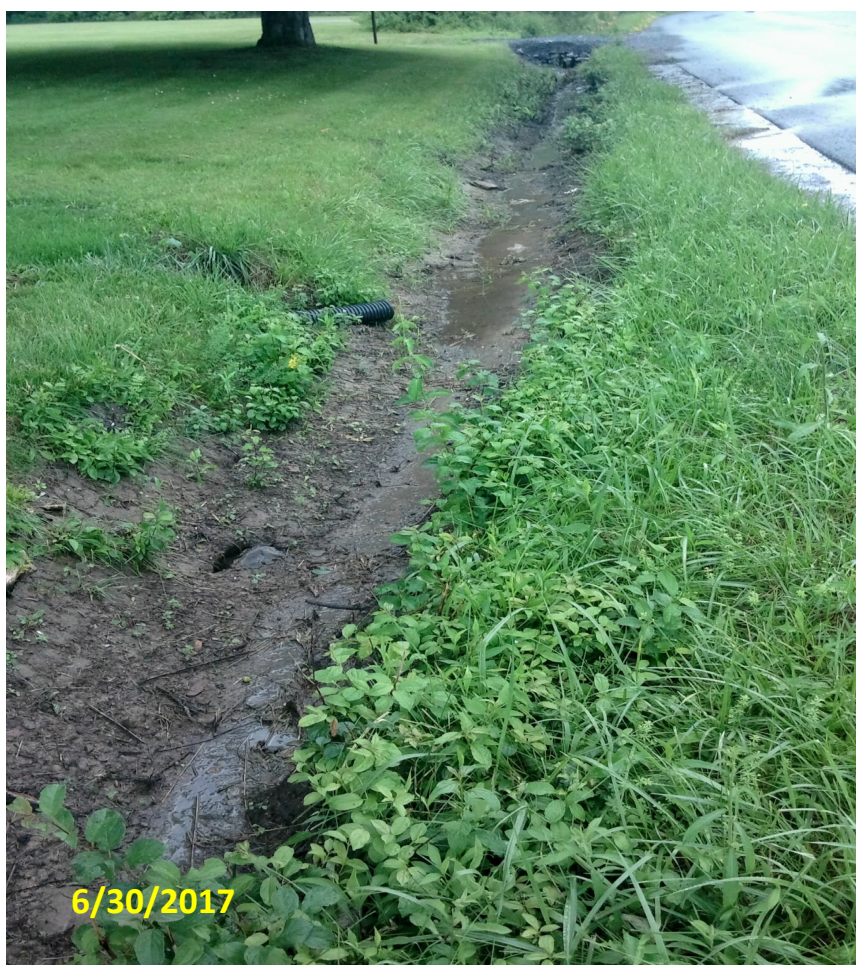
Map Identifier: Site 32
Sub-watershed: Unknown
Road Name: Rockefeller Road
Town: Owasco
Road Jurisdiction: Cayuga County Highway
Closest Intersection: Rockefeller Road/State Route 38A
Direct connection or proximity to a stream?: Yes
Percent Vegetation & Type: 25% Grasses
Level of Erodibility: Moderate
Slope of Area: Moderate Grade
Length of Ditch: 100 ft
Management Recommended: Hydroseeding
Resolvability: Simple

Rank: High (Score = 40)
Estimated Cost: \$150

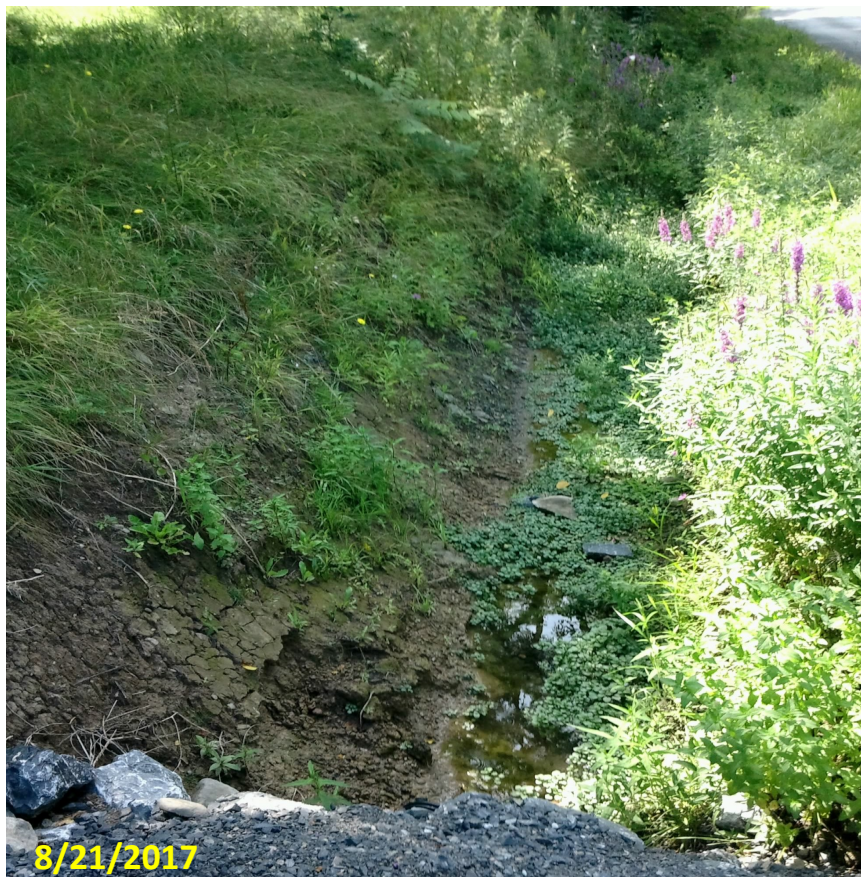
Map Identifier: Site 33
Sub-watershed: Unknown
Road Name: Rockefeller Road
Road Jurisdiction: Cayuga County Highway
Closest Intersection: Rockefeller Road/Fire Lane 14
Direct connection or proximity to a stream?: Yes
Percent Vegetation & Type: 50% Grasses
Level of Erodibility: Moderate
Slope of Area: Moderate Grade
Length of Ditch: 200 ft
Management Recommended: Hydroseeding
Resolvability: Moderate

Rank: High (Score = 40)
Estimated Cost: \$300

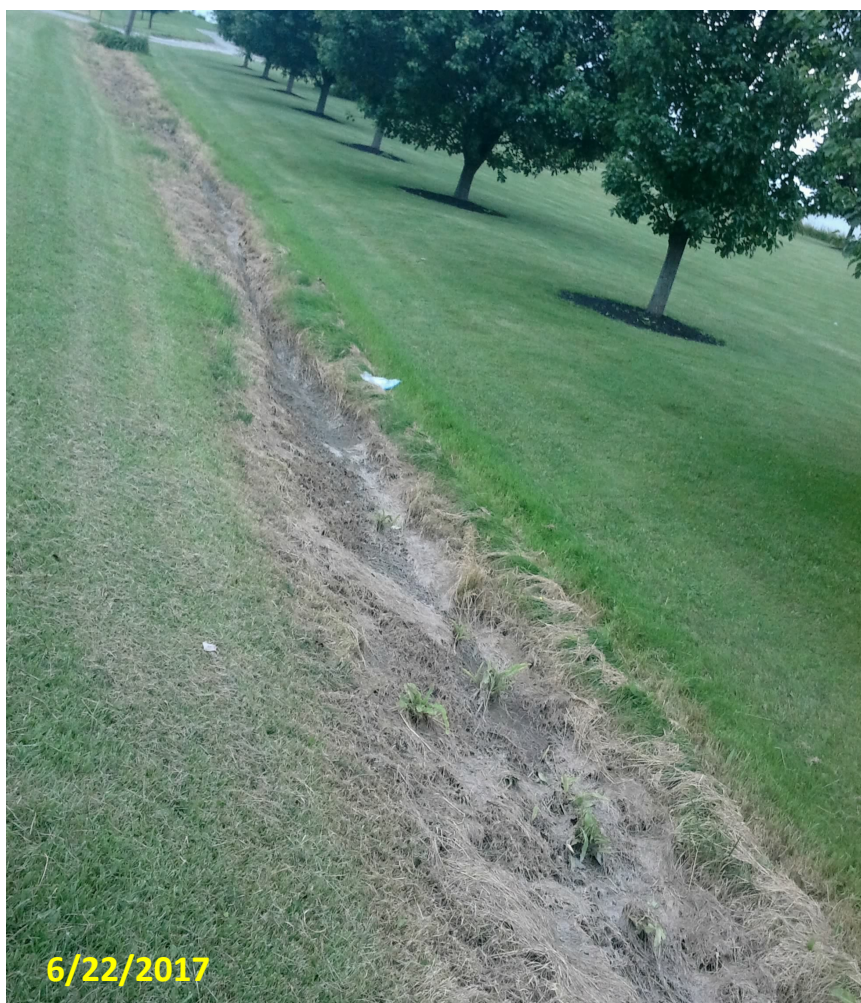
Map Identifier: Site 34
Sub-watershed: Dutch Hollow Brook
Road Name: Valentine Road
Town: Owasco
Road Jurisdiction: Cayuga County Highway
Closest Intersection: Valentine Road/State Route 38A
Direct connection or proximity to a stream?: No
Percent Vegetation & Type: 40% Grasses
Level of Erodibility: Moderate
Slope of Area: Flat
Length of Ditch: 500 ft
Management Recommended: Hydroseeding
Resolvability: Simple

Rank: Moderate (Score = 31)
Estimated Cost: \$750

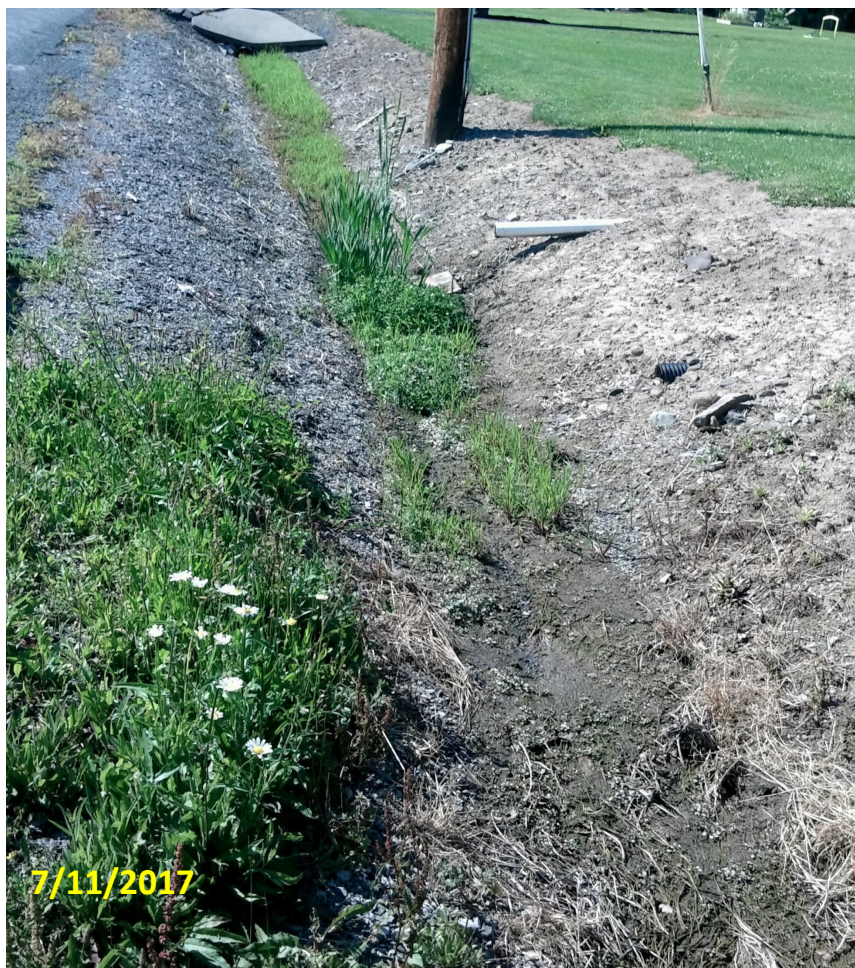
Map Identifier: Site 35
Sub-watershed: Dutch Hollow Brook
Road Name: Twelve Corners Road
Town: Owasco
Road Jurisdiction: Cayuga County Highway
Closest Intersection: Twelve Corners Road/State Route 38A
Direct connection or proximity to a stream?: Yes
Percent Vegetation & Type: 10% Grasses
Level of Erodibility: Moderate
Slope of Area: Moderate Grade
Length of Ditch: 100 ft
Management Recommended: Hydroseeding
Resolvability: Simple

Rank: High (Score = 40)
Estimated Cost: \$150
