Owasco Lake Watershed 2017 Roadside Ditch Assessment

Road Ditch Assessment Sites in Scipio (Cayuga County)

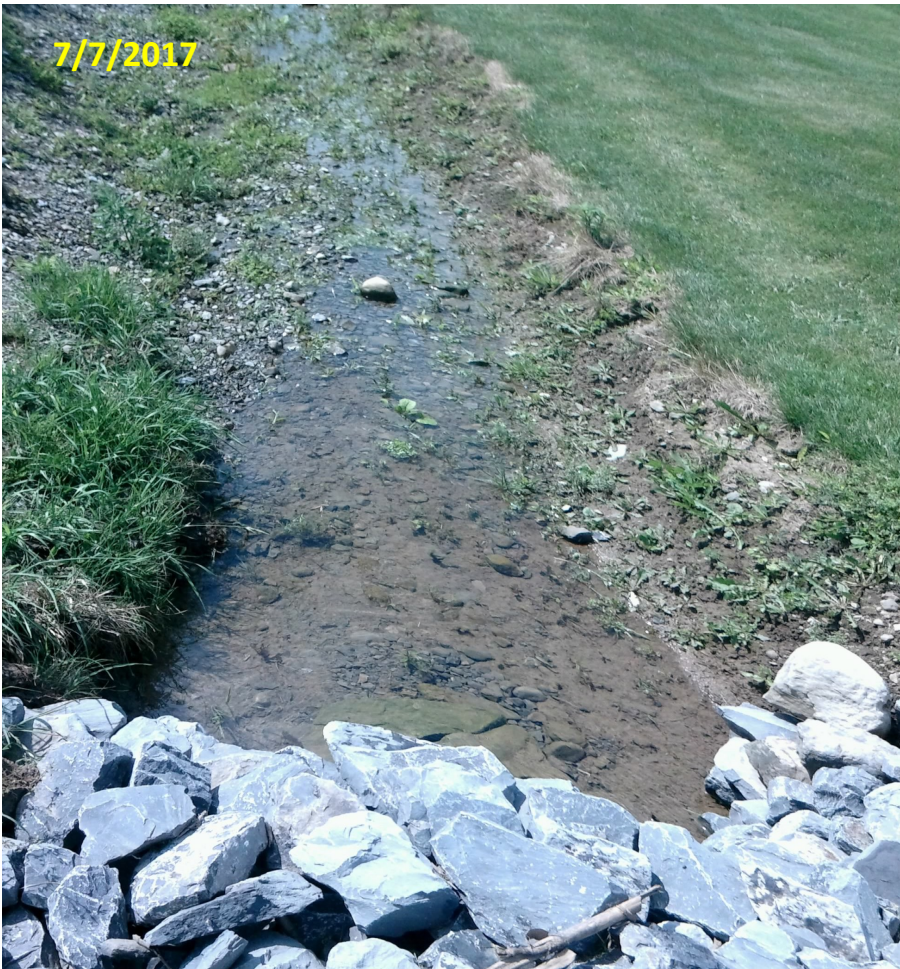
Map Identifier: Site 6
Sub-watershed: Unknown
Road Name: Rice Road
Town: Scipio
Road Jurisdiction: Town of Scipio
Closest Intersection: Rice Road/Hunter Road
Direct connection or proximity to a stream?: No
Percent Vegetation & Type: 50% Grasses
Level of Erodibility: Moderate
Slope of Area: Flat
Length of Ditch: 150 ft
Management Recommended: Hydroseeding
Resolvability: Simple

Rank: Moderate (Score = 21)
Estimated Cost: \$225

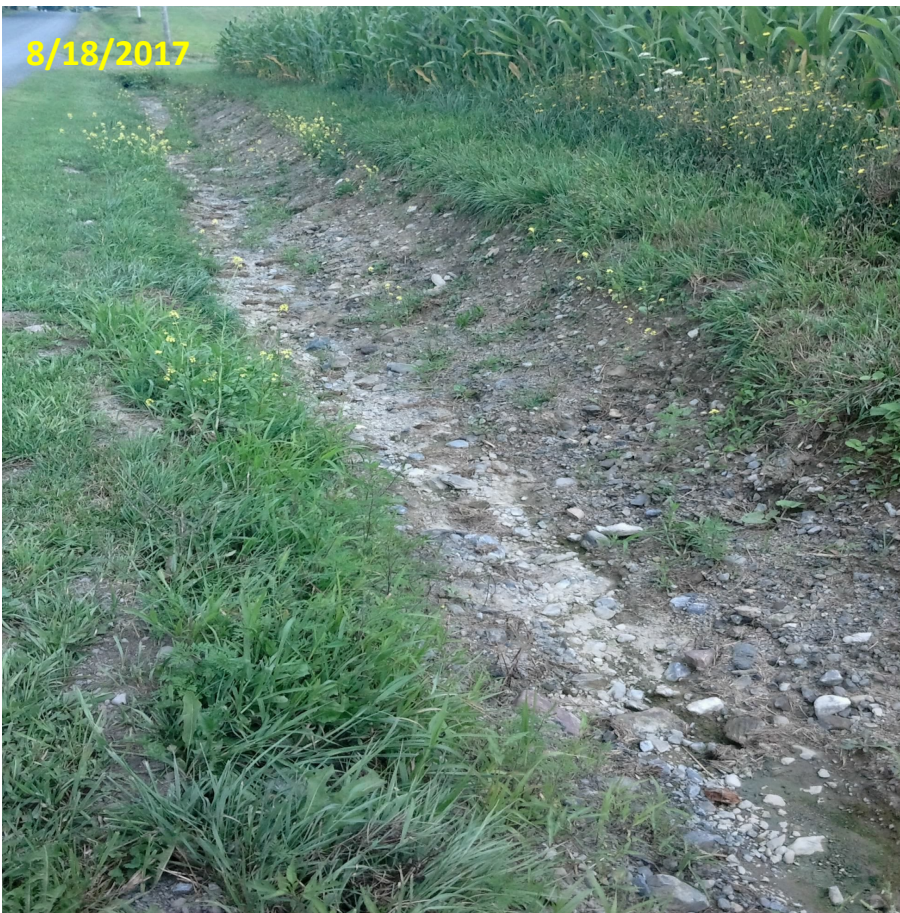
Map Identifier: Site 7
Sub-watershed: Unknown
Road Name: Hunter Road
Town: Scipio
Road Jurisdiction: Town of Scipio
Closest Intersection: Hunter Road/Rice Road
Direct connection or proximity to a stream?: No
Percent Vegetation & Type: 10% Grasses
Level of Erodibility: Moderate
Slope of Area: Moderate Grade
Length of Ditch: 100 ft
Management Recommended: Hydroseeding
Resolvability: Simple

Rank: Moderate (Score = 30)
Estimated Cost: \$150

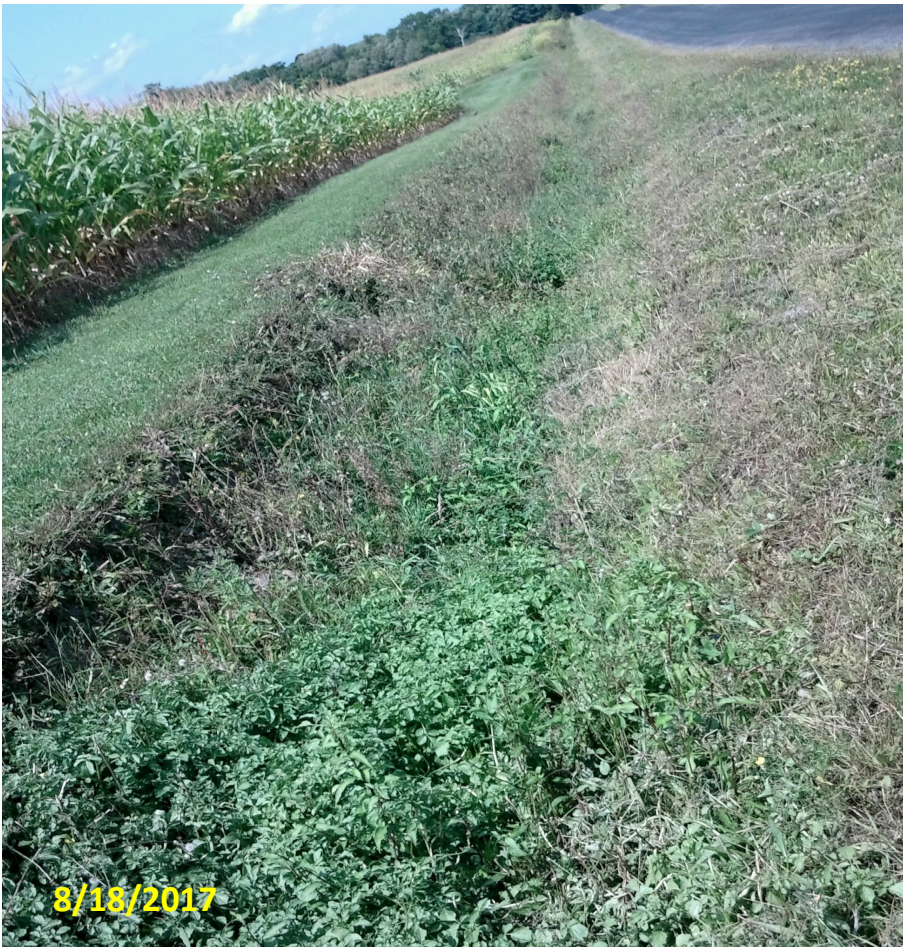
Map Identifier: Site 8
Sub-watershed: Unknown
Road Name: Wyckoff Road
Town: Scipio
Road Jurisdiction: Cayuga County Highway
Closest Intersection: Wyckoff Road/Hicks Road
Direct connection or proximity to a stream?: Yes
Percent Vegetation & Type: 80% Grasses
Level of Erodibility: Low
Slope of Area: Moderate Grade
Length of Ditch: 250 ft
Management Recommended: Hydroseeding
Resolvability: Simple

Rank: Moderate (Score = 27)
Estimated Cost: \$375

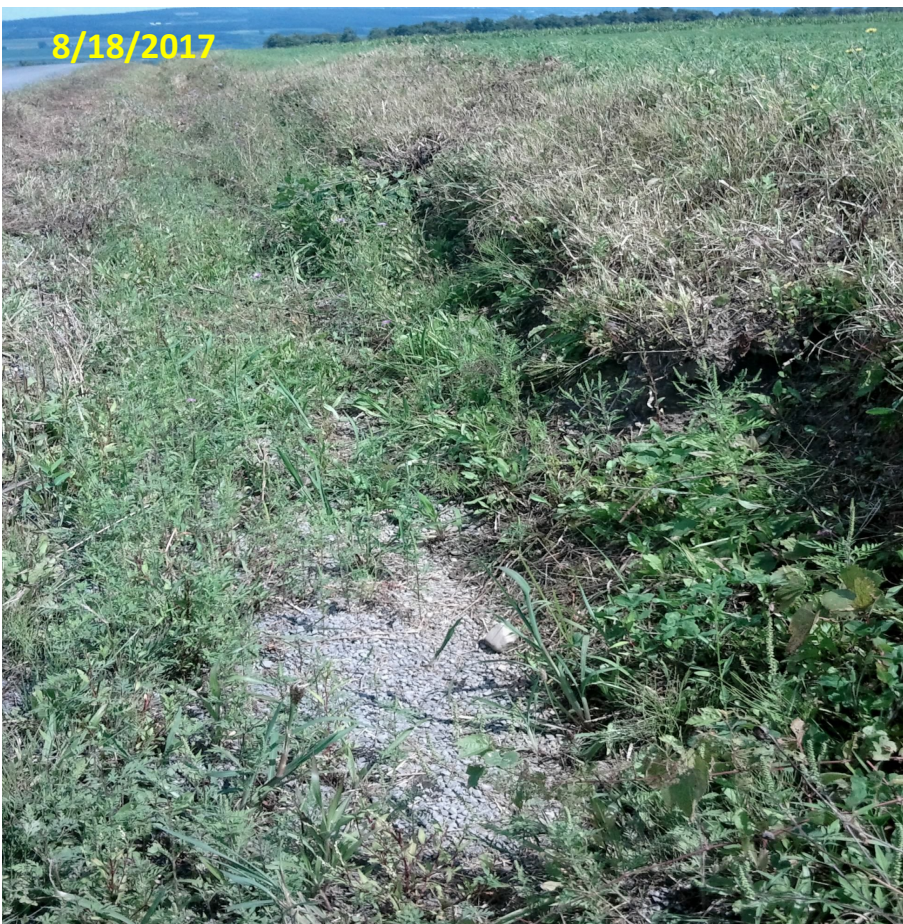
Map Identifier: Site 9
Sub-watershed: Unknown
Road Name: Hicks Road
Town: Scipio
Road Jurisdiction: Town of Scipio
Closest Intersection: Hicks Road/Wyckoff Road
Direct connection or proximity to a stream?: No
Percent Vegetation & Type: 80% Grasses
Level of Erodibility: Low
Slope of Area: Moderate Grade
Length of Ditch: 3,300 ft
Management Recommended: Hydroseeding
Resolvability: Simple

Rank: Moderate (Score = 22)
Estimated Cost: \$4,950

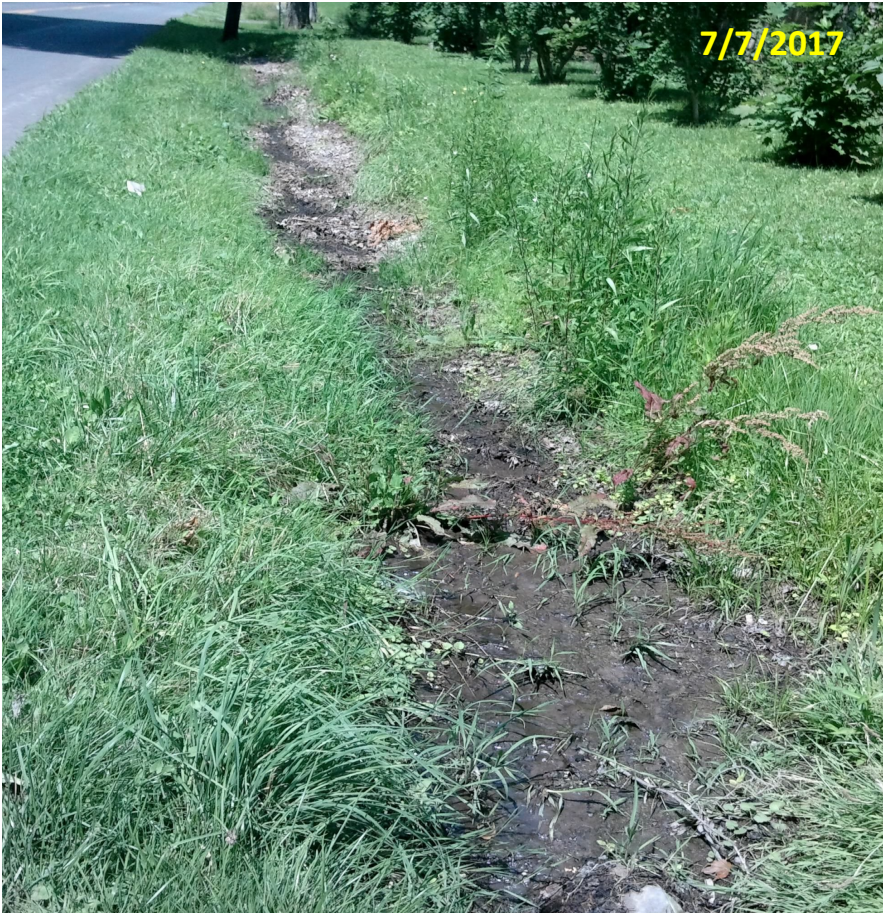
Map Identifier: Site 10
Sub-watershed: Unknown
Road Name: Center Road
Town: Scipio
Road Jurisdiction: Cayuga County Highway
Closest Intersection: Center Road/Lakeview Circle
Direct connection or proximity to a stream?: No
Percent Vegetation & Type: 25% Grasses
Level of Erodibility: Moderate
Slope of Area: Moderate Grade
Length of Ditch: 50 ft
Management Recommended: Hydroseeding
Resolvability: Moderate

Rank: Moderate (Score = 30)
Estimated Cost: \$75

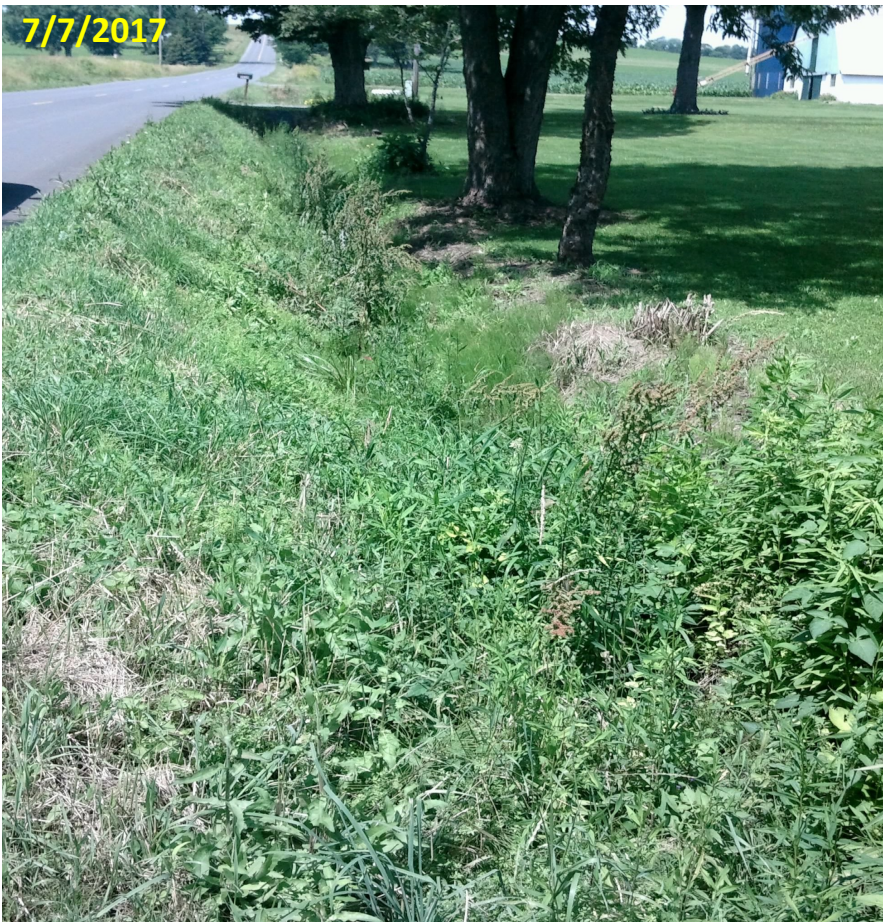
Map Identifier: Site 11
Sub-watershed: Unknown
Road Name: Center Road
Town: Scipio
Road Jurisdiction: Cayuga County Highway
Closest Intersection: Center Road/Lakeview Circle
Direct connection or proximity to a stream?: No
Percent Vegetation & Type: 80% Grasses
Level of Erodibility: Low
Slope of Area: Moderate Grade
Length of Ditch: 200 ft
Management Recommended: Hydroseeding
Resolvability: Simple

Rank: Low (Score = 17)
Estimated Cost: \$300

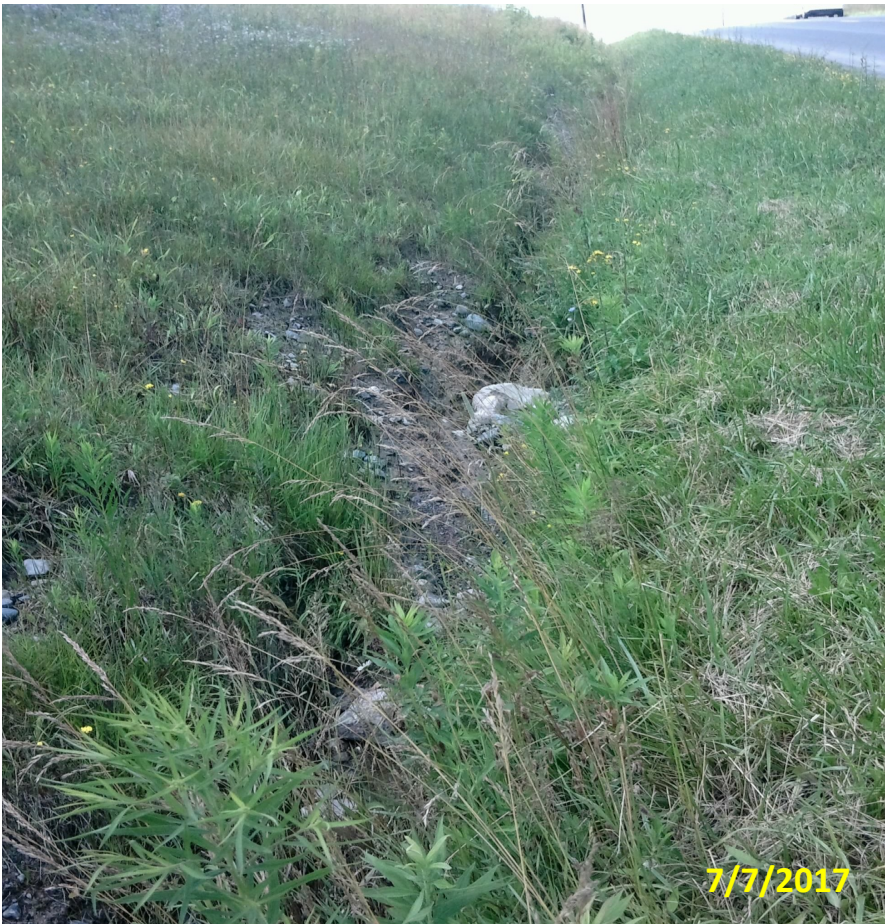
Map Identifier: Site 12
Sub-watershed: Unknown
Road Name: Center Road
Town: Scipio
Road Jurisdiction: Cayuga County Highway
Closest Intersection: Center Road/Wyckoff Road
Direct connection or proximity to a stream?: No
Percent Vegetation & Type: 75% Grasses
Level of Erodibility: Moderate
Slope of Area: Steep Grade
Length of Ditch: 300 ft
Management Recommended: Hydroseeding
Resolvability: Moderate

Rank: Moderate (Score = 30)
Estimated Cost: \$450

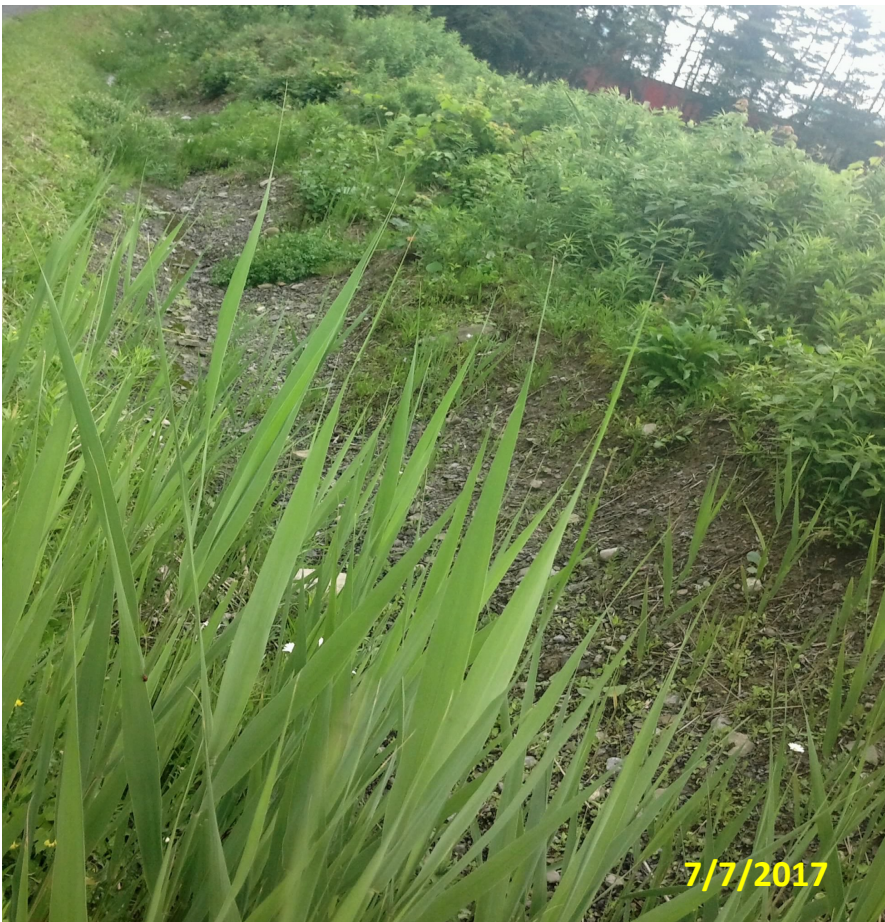
Map Identifier: Site 13
Sub-watershed: Willow Point Tributary
Road Name: Burtless Road
Town: Scipio
Road Jurisdiction: Town of Scipio
Closest Intersection: Burtless Road/Sherwood Road
Direct connection or proximity to a stream?: No
Percent Vegetation & Type: 50% Grasses
Level of Erodibility: Moderate
Slope of Area: Moderate Grade
Length of Ditch: 100 ft
Management Recommended: Hydroseeding
Resolvability: Simple

Rank: Moderate (Score = 25)
Estimated Cost: \$150
